SERVICE NOTE

Signa[®] Service Tools

SN 67031

ANALYZING HSS (HIGH SPEED STABILITY) RESULTS

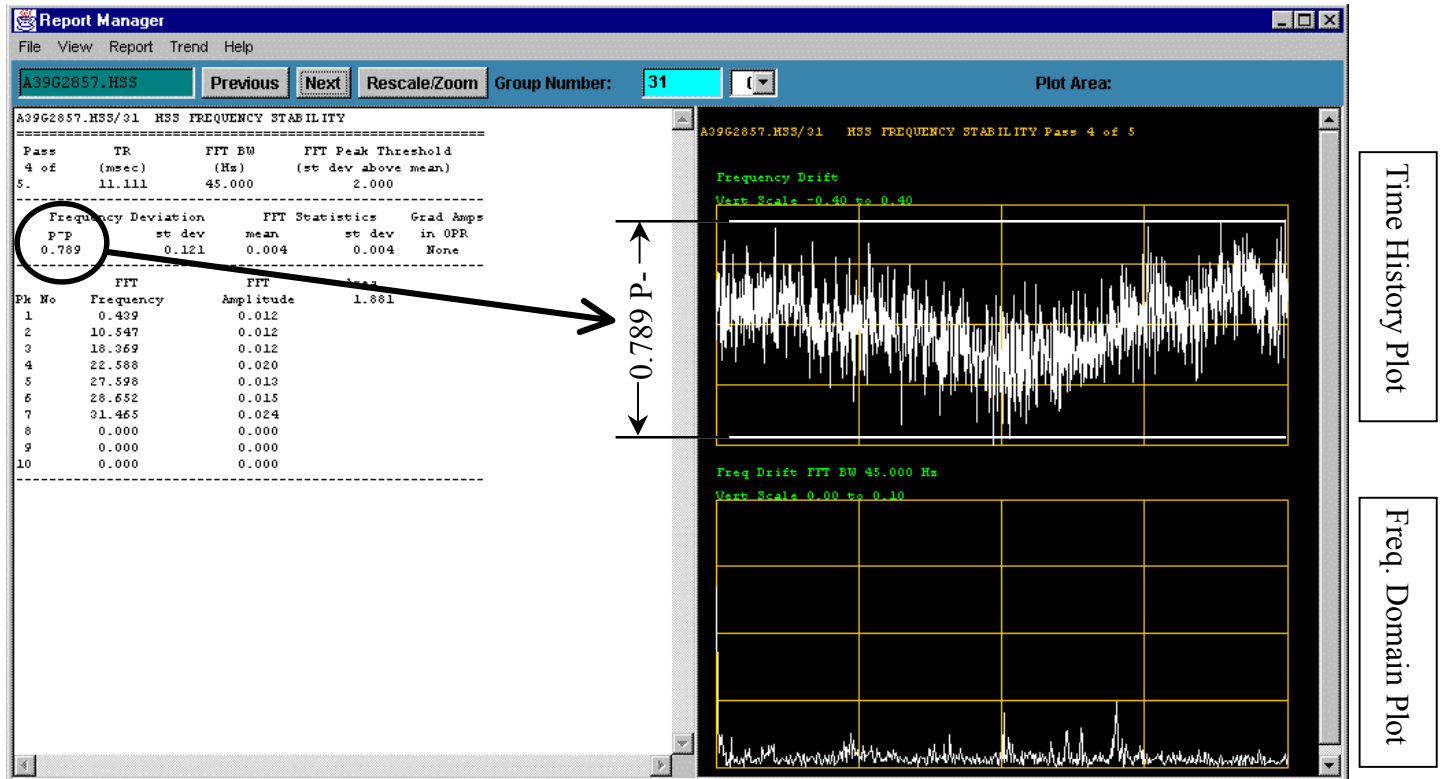
FAILING P-P SPEC.
ILLUSTRATION 1

Review the time history plots. Review each of the 5 individual passes for P-P Frequency Deviation. The maximum allowed frequency instability specification is **0.7 P-P** within a 40cm Diameter Spherical Volume (DSV).

The Time History plots should show a signal with a frequency component that is fairly centered and horizontal on the graph. There should be no upward or downward slope. Abnormalities are displayed as transient bursts, frequency patterns, sloping curves, or low frequency curves (See Illustration 1).

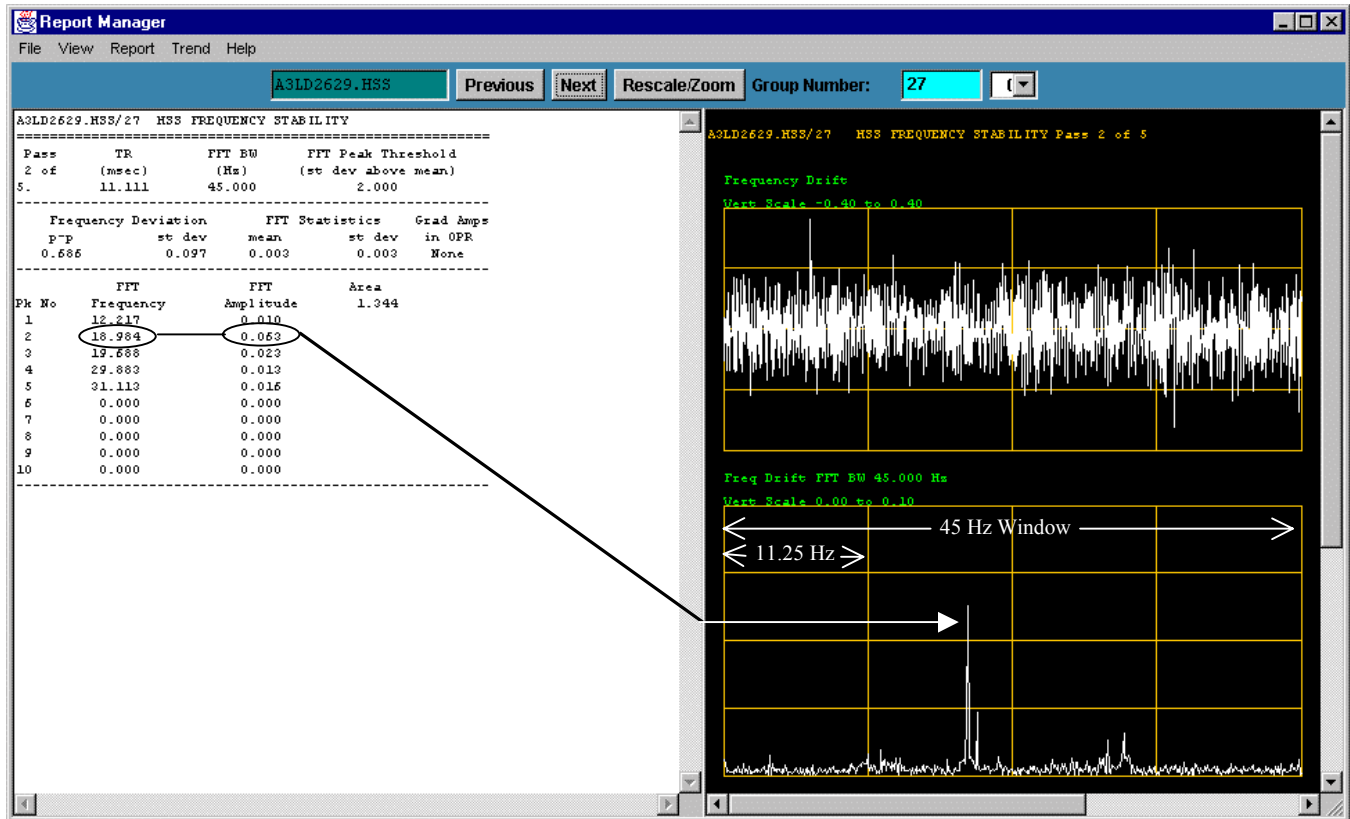
FFT AMPLITUDE SPIKES
ILLUSTRATION 2

The FFT amplitude is an indication of the magnitude/strength of the vibration, or noise at a particular frequency. ILLUSTRATION 2 shows the plot a HVAC fan that is slightly out of balance causing a spike on the FFT graph at a frequency of 18.984 Hz, and with an amplitude of .063 (e.g. ILLUSTRATION 2). A fan that is extremely out of balance could have the same frequency component of 18.984Hz, but the FFT amplitude (spike height) could be 0.1 counts or higher. The higher the spike or FFT amplitude, the greater the amount of area under the spike, causing higher Area, which also may fail spec. **Fix the cause of the spike first, before attempting to fix high Area.**

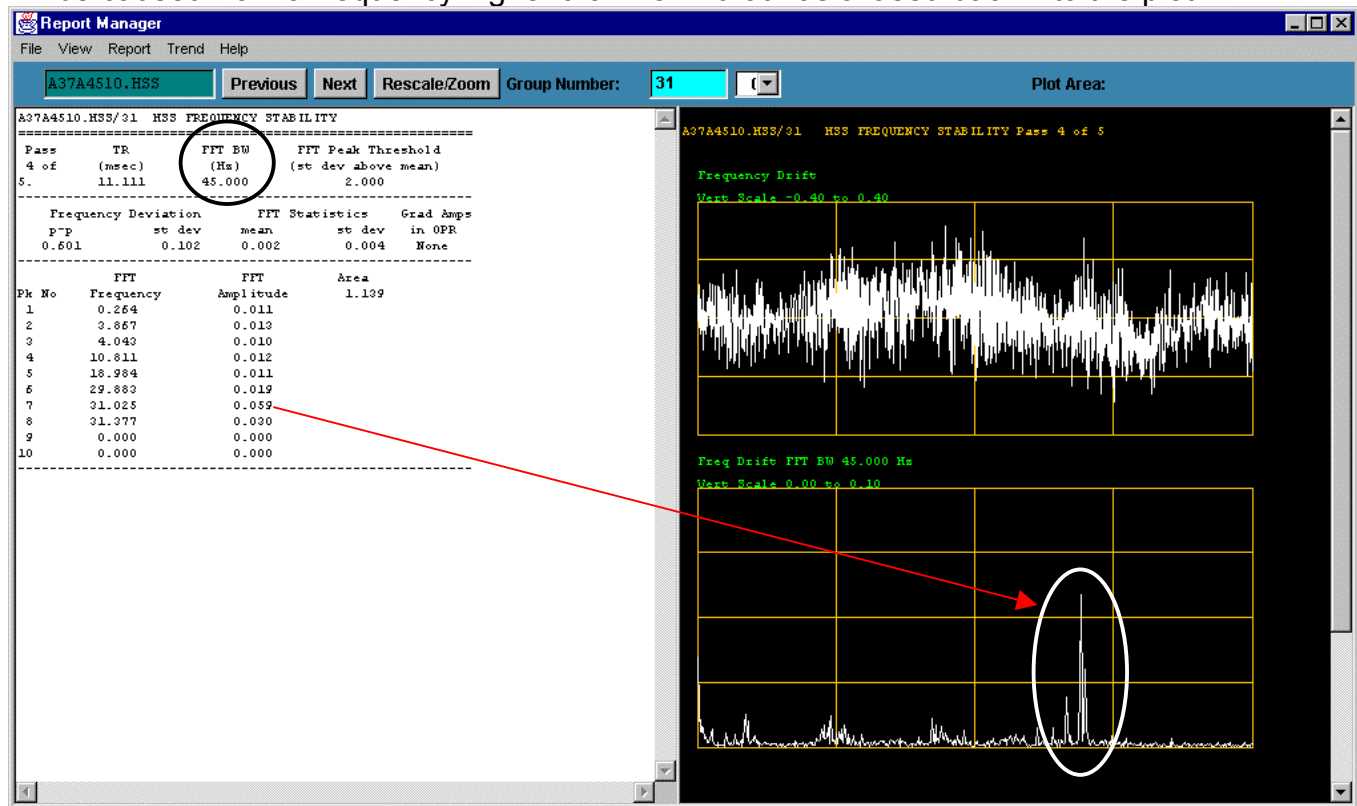
FFT BW = 45HZ
ILLUSTRATION 3

- 1) Perform an HSS scan and analysis in the normal mode. Record output file number.
- 2) Using Report Manager, review the Time History plots, not the averaged plot. The example plot (ILLUSTRATION 3) indicates a high “spike” at 31.025Hz with a FFT amplitude of 0.059. Even though the amplitude is within spec (less than 0.1), it is still unusual. The question to be answered, is 31.025Hz the real frequency, or could this spike be caused from a frequency higher than 45Hz that has aliased back into the plot?

Using the Example from ILLUSTRATION 3:

- $45\text{Hz} - 31\text{Hz} = 14\text{Hz}$ Difference between Reported Freq. and Bandwidth.
- $45\text{Hz} + 14\text{Hz} = \underline{59\text{Hz}}$ Actual Frequency of the disturbance.

Narrow Spikes: If the spike is very narrow (e.g. 1 pixel in width) from the base to the top, and the frequency is consistent with every HSS scan, then the spike may be caused from an electrical source. For example, the 29.833Hz spike seen on systems with a UCERD, is caused by a 60Hz harmonic feedback from the UCERD. This is a known pattern for a UCERD and the amplitude is usually small in normal situations. (See ILLUSTRATION 3, Pk No 5 (peak number 5).)

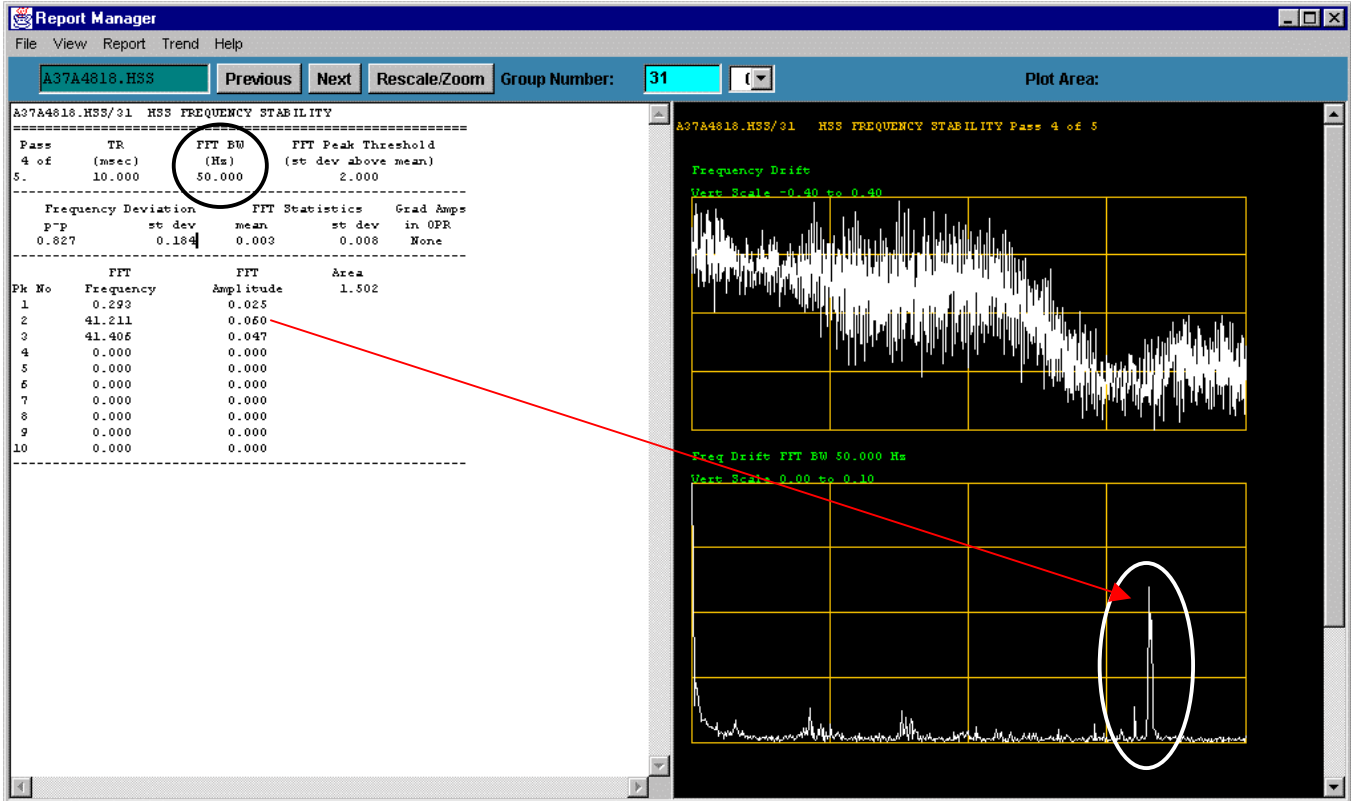
FFT BW = 50HZ
ILLUSTRATION 4

- Spike is at 31.025 Hz in the 45Hz BW scan.
- Expanding the Bandwidth to 50Hz, the spike moves to the right and is now reported as 41.211Hz (see Figure 4). *This indicates that the natural frequency is above the 45Hz window.*

$50\text{Hz} - 41\text{Hz} = 9\text{Hz}$ Difference between Reported Freq. and Bandwidth.

$50\text{Hz} + 9\text{Hz} = \underline{59\text{Hz}}$ Actual Frequency of the disturbance.

Wide Spikes: If there is some bandwidth to the spike and/or the frequency drifts slightly from one scan to another, then the spike is usually mechanical in nature. (See ILLUSTRATION 4, Pk No 2.) Check for mechanical vibrations from various components. See Table 1.

10.) Troubleshoot and find root cause of component that is vibrating at 59Hz.

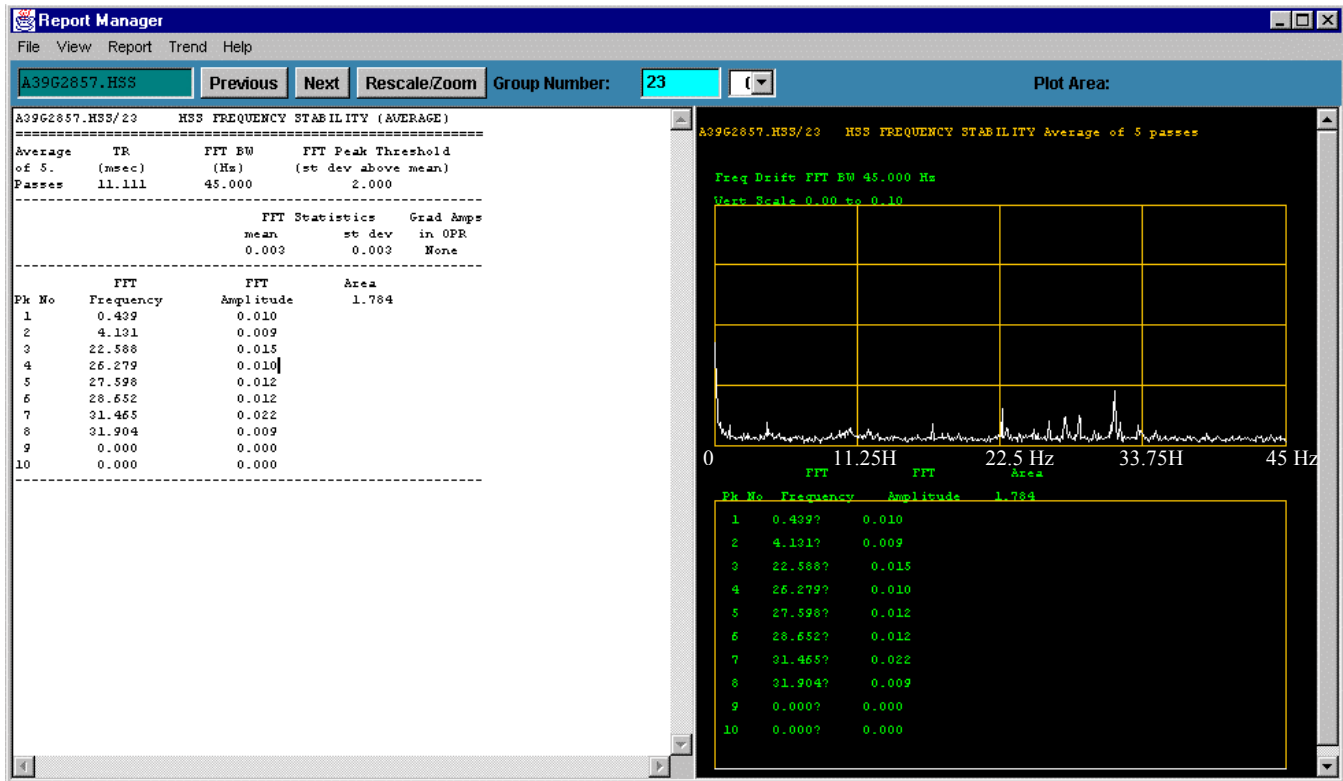
AVERAGE OF 5 PASSES
ILLUSTRATION 6

Example of a relatively good HSS plot with elevated Area is shown in ILLUSTRATION 6. This graph shows a relatively flat plot with few, low spikes, however the Area is calculated to be 1.784 which is above Area spec (1.2). *Note the elevated baseline (e.g. the baseline is not at zero).*

The example in ILLUSTRATION 6 clearly shows the effect of broadband noise. To reduce the broadband noise, the following must be used when executing HSS tests to meet the HSS Area specification:

- Revision 8.3 M5 (or later) System Software (Has revised PSD to compensate for UCERD Phase noise) and,
- Alternative method using the signal from the Head Port through an attenuator (to compensate for noise coming from the RFI). See ILLUSTRATION 7.

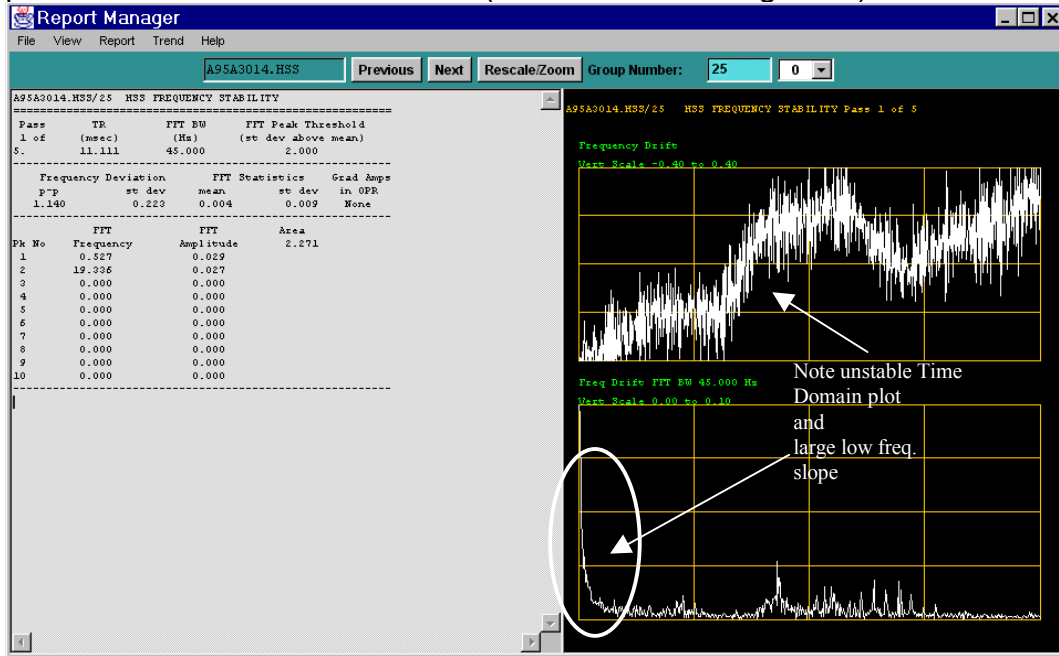
STANDARD, UN-FILTERED PLOTS
ILLUSTRATION 11

If strong winds are present and the HSS plot indicates a intermittent high P-P signal in the Time History plots AND the Amplitude plots indicates a slope from 0 – 2 Hertz with a “Hump” near 3- 4 Hz and 10-11 Hz (which indicates van rocking, as seen in ILLUSTRATION 11), then it may be appropriate to use the Hanning Filter. Otherwise, use of the Hanning Filter may mask other System or Van related problems.

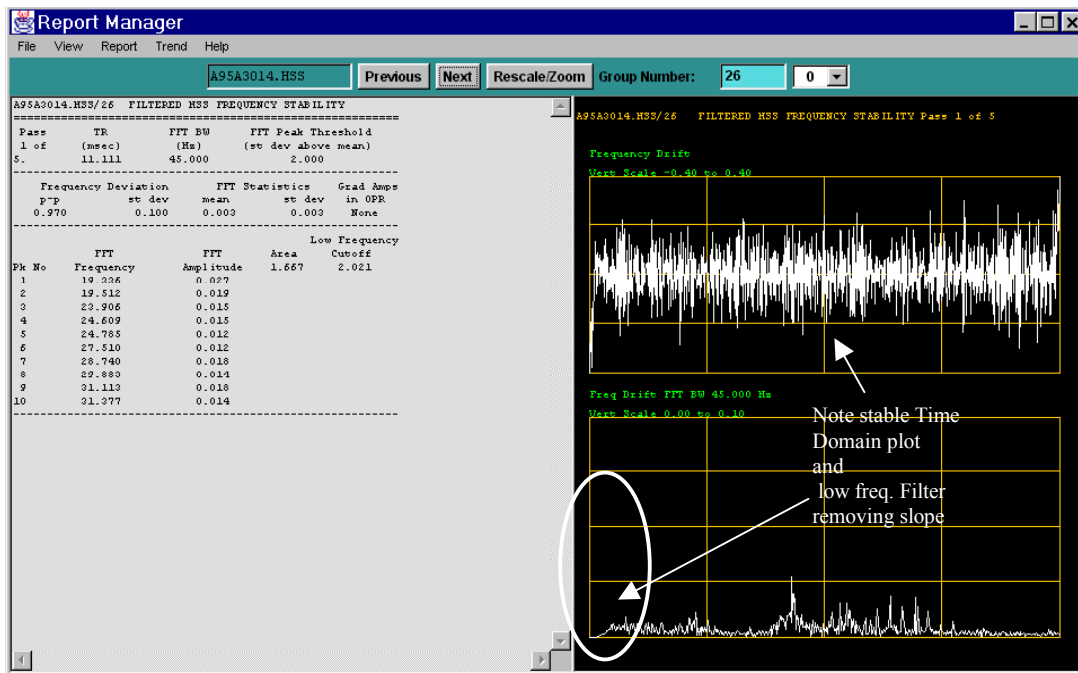
HANNING FILTER PLOT
ILLUSTRATION 12

Be aware that use of the Hanning Filter, will put a glitch and a spike at the beginning and the end of the time history plot, that will drive the P-P Frequency Deviation number out of spec. Determine the actual P-P Deviation by interpreting the plot. In the example above, Figure 12 the Time History Plot (Frequency Drift) the X scaling is +/- 0.4. Ignoring the artifact at the very beginning and very end of the plot caused by the Hanning Filter the P-P Frequency Deviation is about 0.28.
