SERVICE NOTE

Signa® Images / Artifacts

SN 67038

DWEPI ARTIFACTS DUE TO GRADIENT COIL MECHANICAL ROCKING

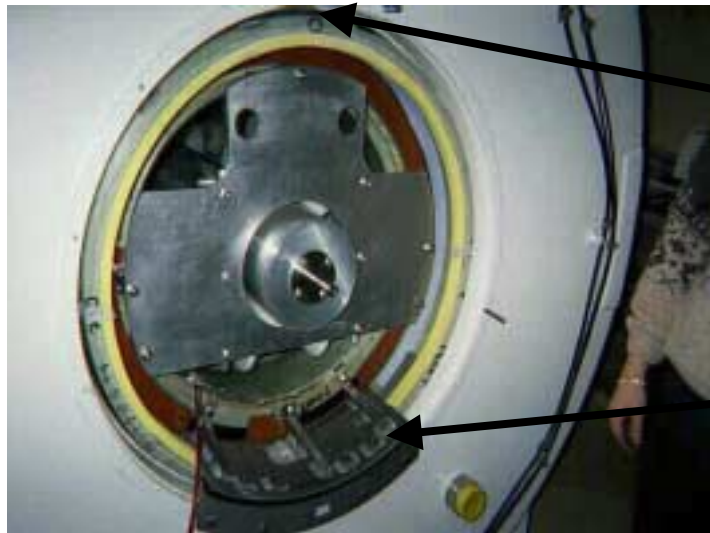
ORIGINAL GRADIENT COIL SUPPORT ILLUSTRATION 1

The foam rope was installed between the outer diameter of the gradient coil to focus the forced cooling air into the space between the inner gradient coil and the RF body coil cartridge.

Rope Air Seal – provides coil mechanical stability plus prevents airflow away from RF coil.

Coil Aluminum extension plate.

Aluminum coil support bracket – bolts to magnet end flange.

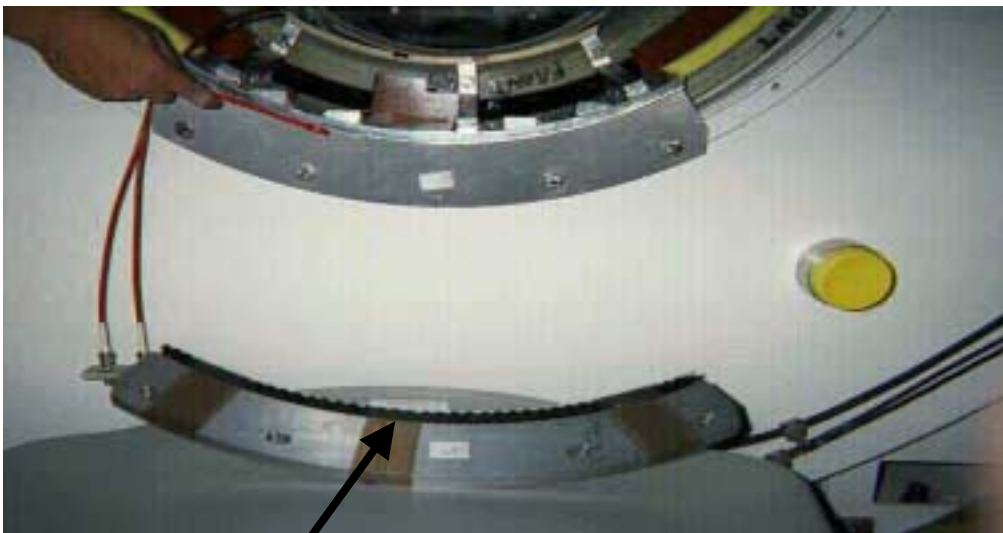
GRADIENT ISOLATION KIT REPLACED THE HARD MOUNTED COIL SUPPORT
ILLUSTRATION 2

Gradient Isolation Kit – consisting of a low profile coil support bracket and a matrix isolation material.

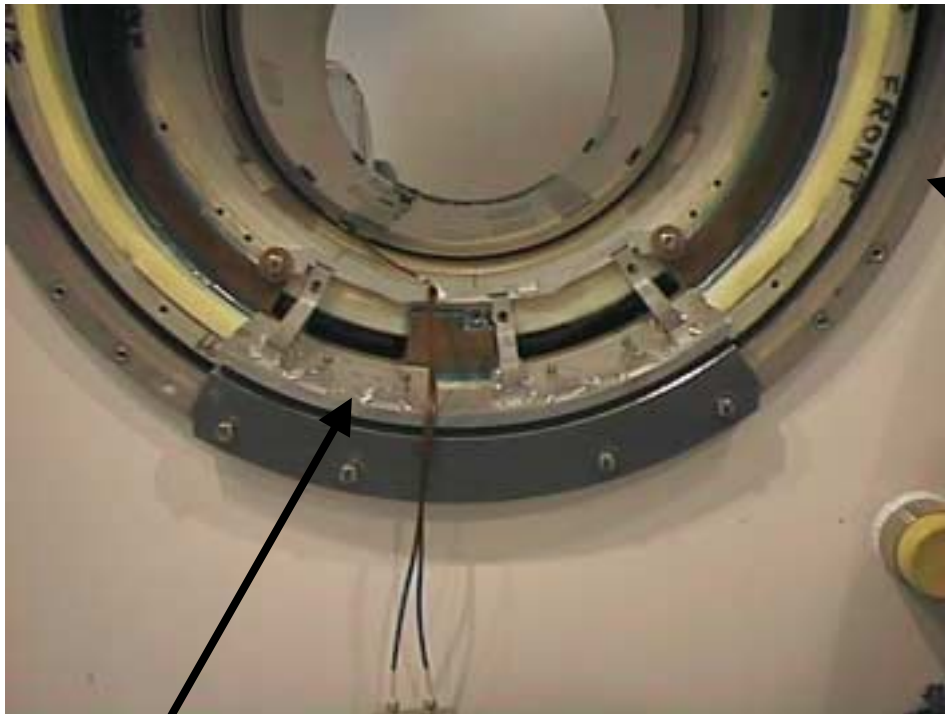
LCC MAGNET FIT WITH GRADIENT ISOLATION KIT ILLUSTRATION 3

Air seal fills gap providing lateral coil support.

The layered matrix isolation material is sandwiched between the coil aluminum extension plate and the aluminum coil support bracket.

THE AIR SEAL REQUIRES A UNIFORM GAP BETWEEN THE COIL OUTER DIAMETER AND INNER DIAMETER OF THE MAGNET WARM BORE.

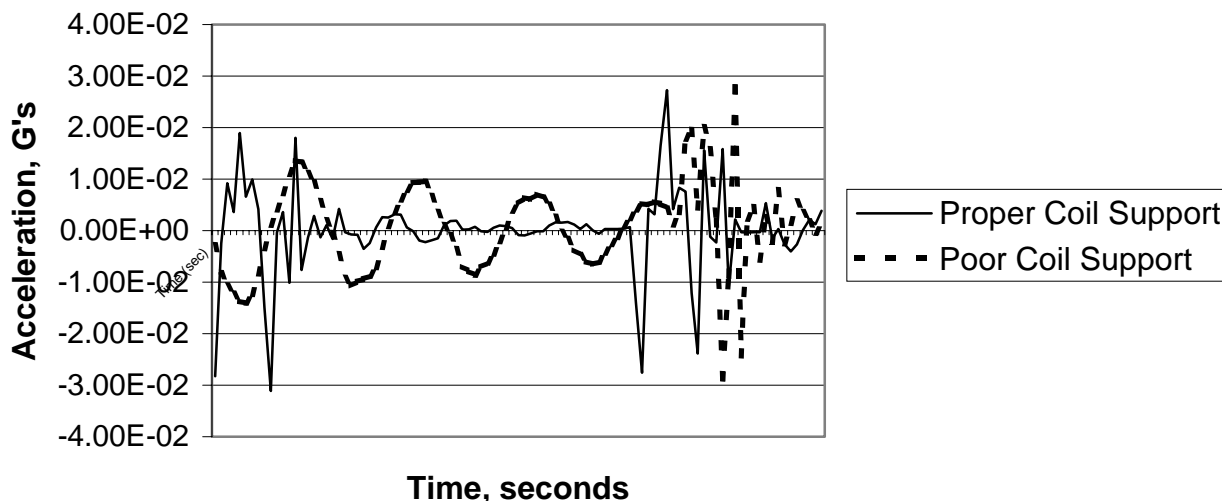
ILLUSTRATION 4

The DW-EPI scan applies a large static gradient pulse prior to data acquisition for image reconstruction. The large current applied to the gradient coil sets up a differential force between the magnet main field and the magnetic field generated in the gradient coil. Without lateral gradient coil support, the coil displaces in a direction opposed by the opposing gradient coil field and the main field. When the large current is removed, gravity allows the gradient coil to rock into a position of static equilibrium. When little or no coil support, primarily lateral support, exists, the coil will rock and decay proportional to the damping of the unstable gradient coil. The dashed curve in Illustration 4 shows the gradient coil motion after the diffusion pulse is removed, for a poorly supported coil. It is the large oscillatory motion that generates the pixel void. The solid curve is the gradient coil response for a coil properly supported. Notice the system has a small initial static offset and the coil damps to a rest position quickly. Where as the dashed curve clearly has a static offset that continues to oscillate until the next diffusion pulse is applied.

POTENTIAL GRADIENT COIL MOTION DURING A DWEPI SCAN

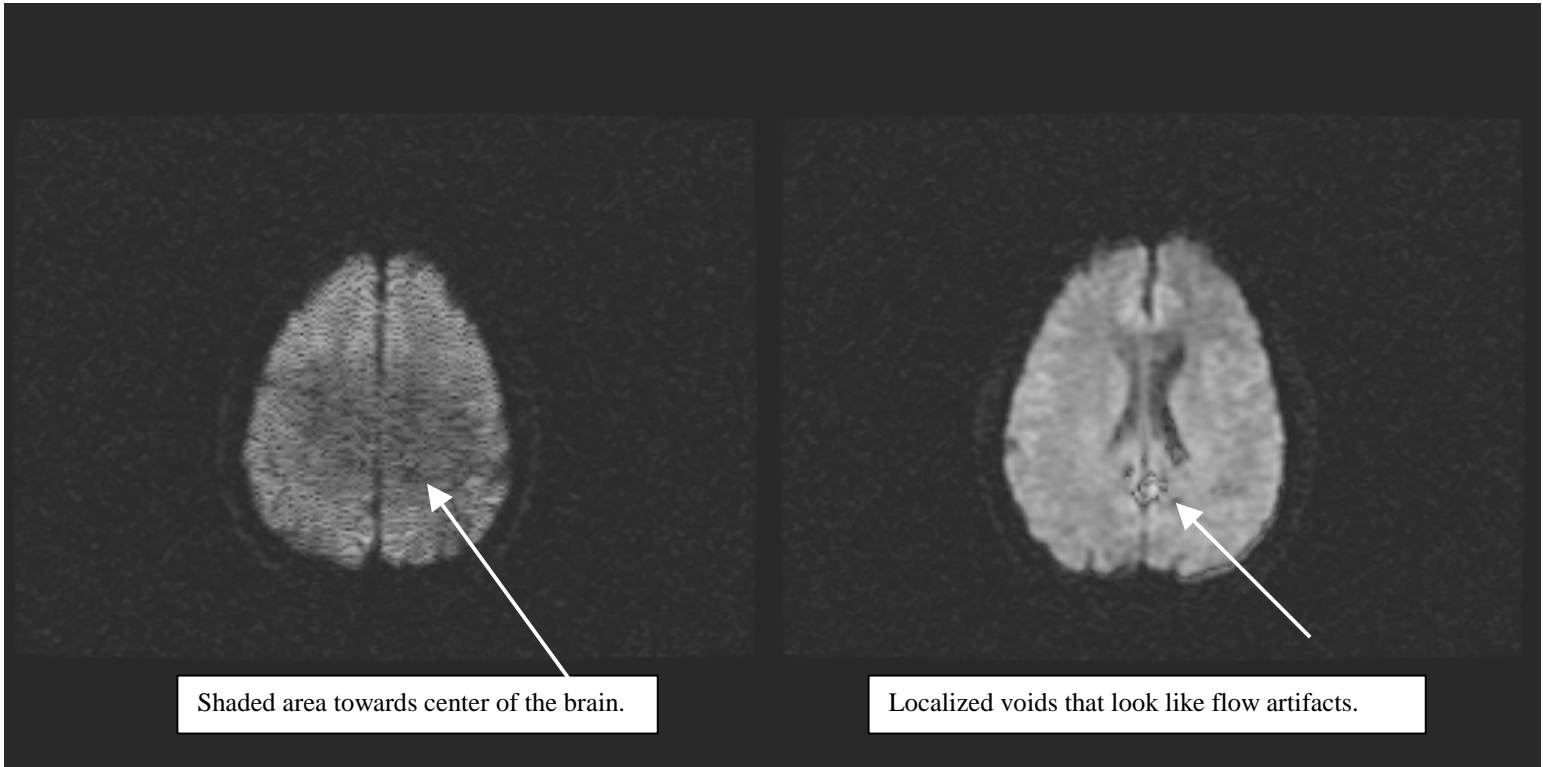
EXAMPLES OF ARTIFACTS DUE TO GRADIENT COIL MOTION WITH DWEPI
ILLUSTRATION 5

Late 1999, a new customer image quality issue surfaced affecting DW-EPI scan sequences. Refer to Illustrations 5 and 6 for the artifacts generated. The primary root cause is due to the gradient coil rocking within the bore. Magnets with the original hard mounted gradient coil support have not experienced this artifact.

The result of this motion can manifest itself in different ways, depending upon the amount of coil and patient movement as well as the anatomical region. Below are some examples of the different ways this artifact can appear.

An RCAT (R4391JA for BRM's and R4391JB for CRM's) was created for the field to order should a site suffer from the vibro-acoustic noise issue. These RCATS now also include the radial supports. The solution to resolve this DW-EPI artifact is to order the appropriate RCAT and install the radial supports as described in pages 8 through 11 of this Service Note.

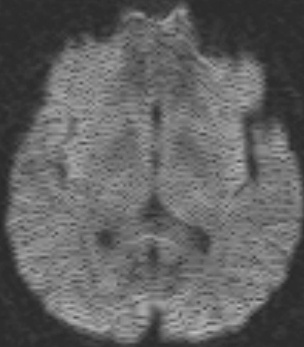
Discrete voids throughout the entire brain.

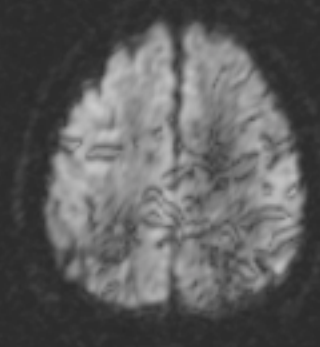
Structured voids throughout the brain.

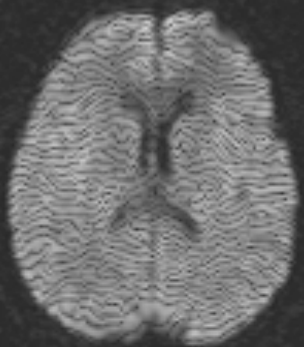
Wavy voids throughout the entire brain.

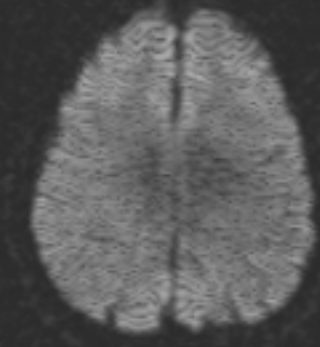
Combined voids, such as shading and discrete voids.

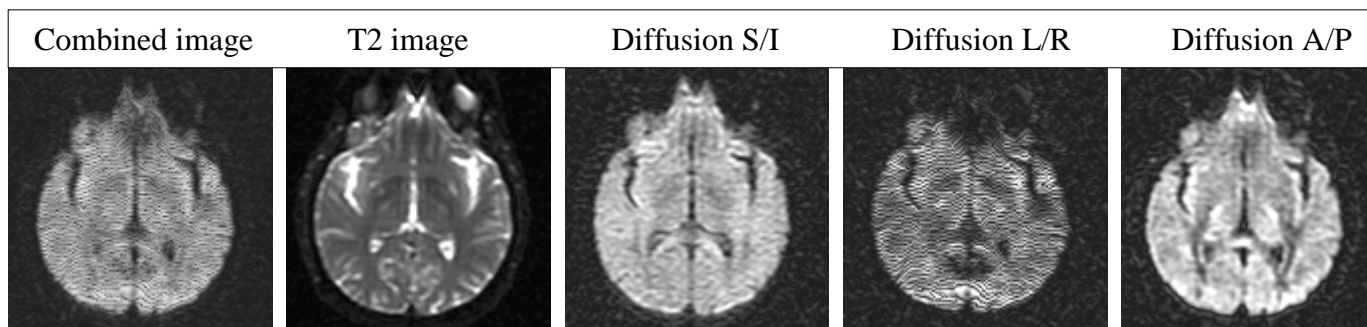
IMAGES ORDER WHEN RECON ALL IS SELECTED FROM DIFFUSION OPTIONS
ILLUSTRATION 9

The following Illustrations (9 through 13) are used to demonstrate how to diagnose diffusion voids that are caused by mechanical motion of the gradient coil. As mentioned earlier these artifacts are not reproducible on phantom scans and therefore clinical or volunteer scans are needed. Also as we mentioned earlier, you must look at the component images. Normally only the combined image (the vectored sum of the 3 component images) along with a T2-weighted EPI image are displayed to the user. The component images are the actual images acquired while the diffusion-sensitizing gradients are applied. Each component image differs only in which physical axis the diffusion gradient is applied (X, Y or Z). To view the component images "recon all" must be selected from Diffusion options area, prior to the scan. This option is available only if the site has a research key or "geservice" is used as the patient id. When "recon all" is selected all the images from the diffusion scan are displayed, see Illustration 9.

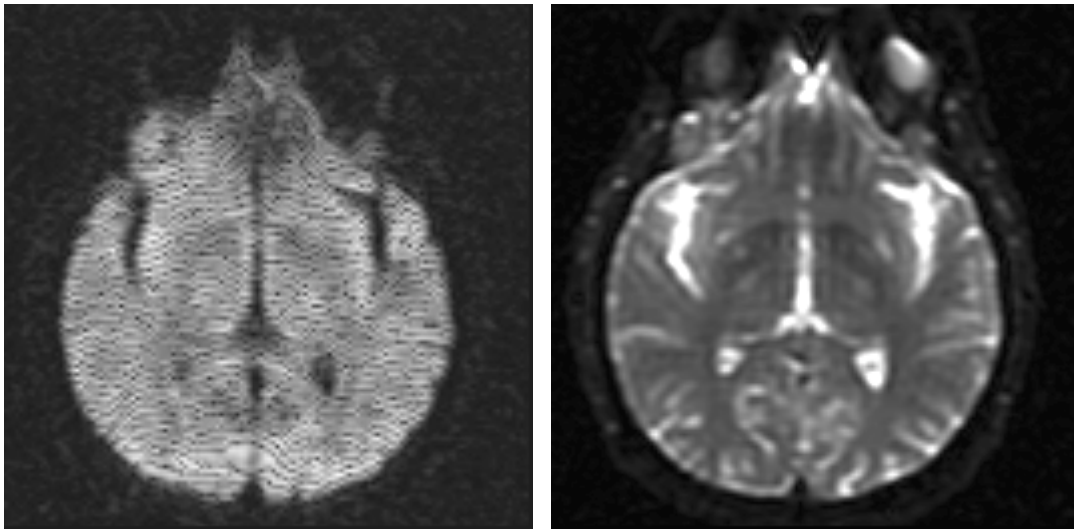
THE COMBINED AND T2 IMAGES
ILLUSTRATION 10

Zooming in on these images to further illustrate the nature of the artifact you can see that the artifact will always be in the combined image but not in the T2 image, since there was no diffusion pulse applied.

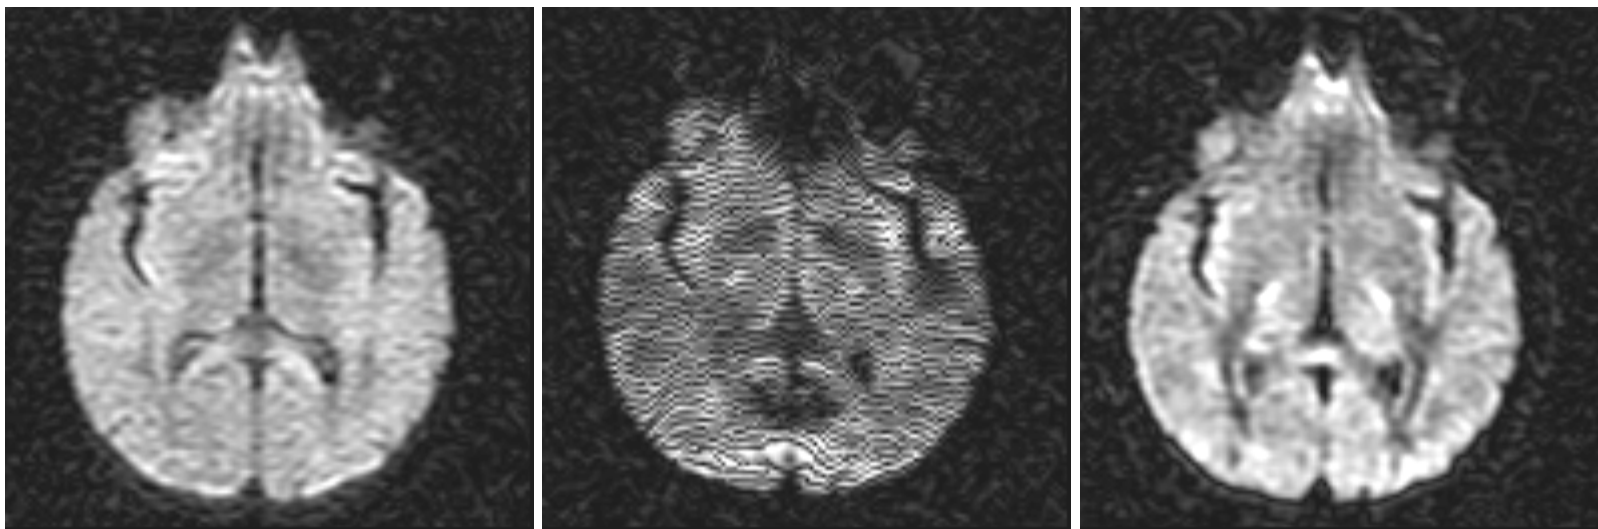
ARTIFACT FOUND ON IMAGE WITH DIFFUSION APPLIED L/R
ILLUSTRATION 11

Examination of the components images show that that artifact occurred when the diffusion gradient was applied along the physical X-axis (L/R), see Illustration 11.

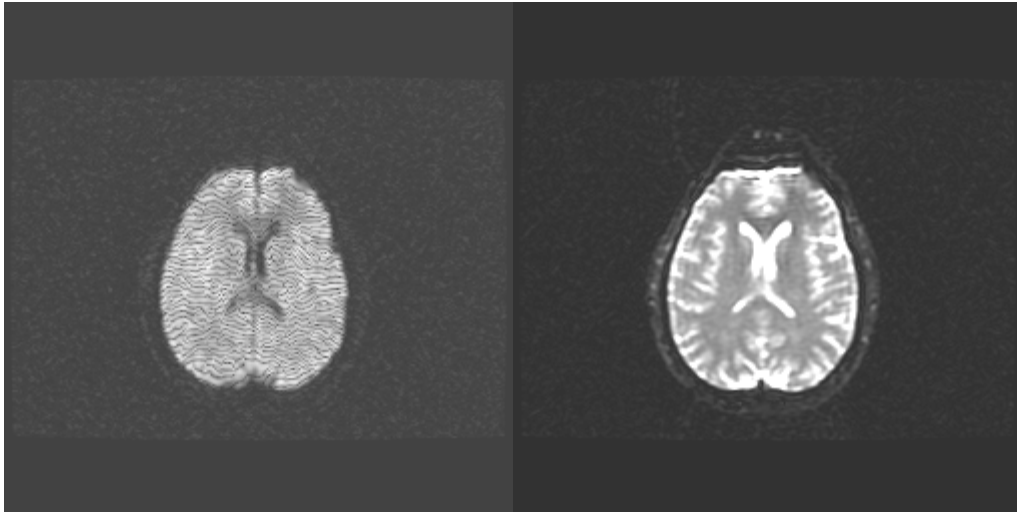
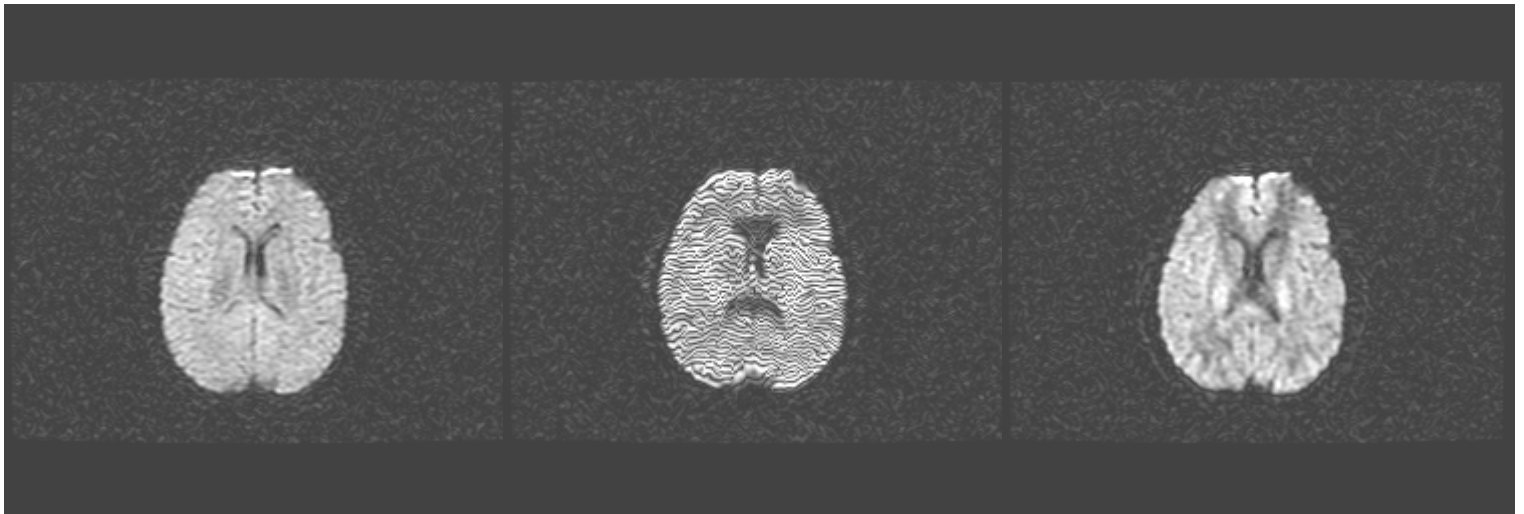
**EXAMPLES, WITH COMPONENT IMAGES DEMONSTRATING GRADIENT COIL MOTION IN L/R
DIRECTION
ILLUSTRATION 12**

Below are more examples to illustrate that artifacts due to mechanical motion of the gradient coil are predominately seen on the component image where the diffusion gradient was applied L/R, which is the key for diagnosing this type of problem.
