## 1- SCAN ROOM INTERFACE (SRI) TROUBLESHOOTING

The Scan Room Interface Unit can be a source for intermittent and continuous RF leaks from the frequencies generated by the controllers and Integrated circuits within it. It is necessary to open the cover to look at diagnostic LED and service the SRI. Occasionally, it may be necessary to remove the cover to inspect the inside, or reattach fiber optic cables that may have come loose.

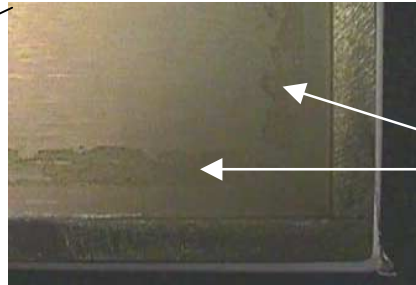
**REMOVE OLD GLUE RESIDUE**  
ILLUSTRATION 1-2

Old glue from previous copper tape.

1. Use Isopropyl Alcohol and thoroughly clean off any old glue or oil residue from the entire edge area before applying new copper tape.

It is essential that all glue and residue is removed from the SRI case before applying new copper tape. (See Section 1-3) Failure to perform section 1-3 will result in intermittent Image Quality problems, White Pixel artifact, Spike noise and possible Zipper artifact in the images.

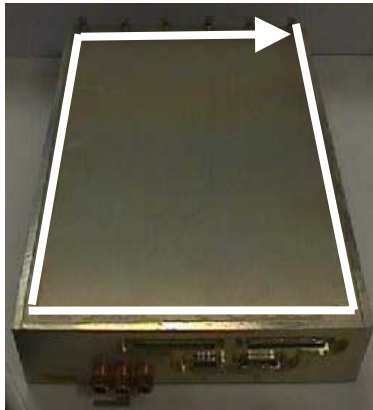
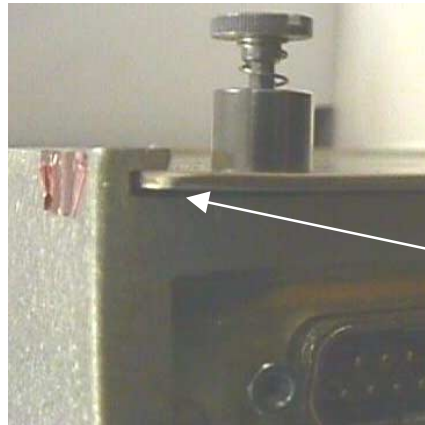
**APPLICATION OF COPPER TAPE**  
ILLUSTRATION 1-4

Watch here for potential leaks, even after copper tape has been applied.

2. Begin applying to entire cover, sealing the gap between the cover and the casing. Work your way around until all gaps are sealed.

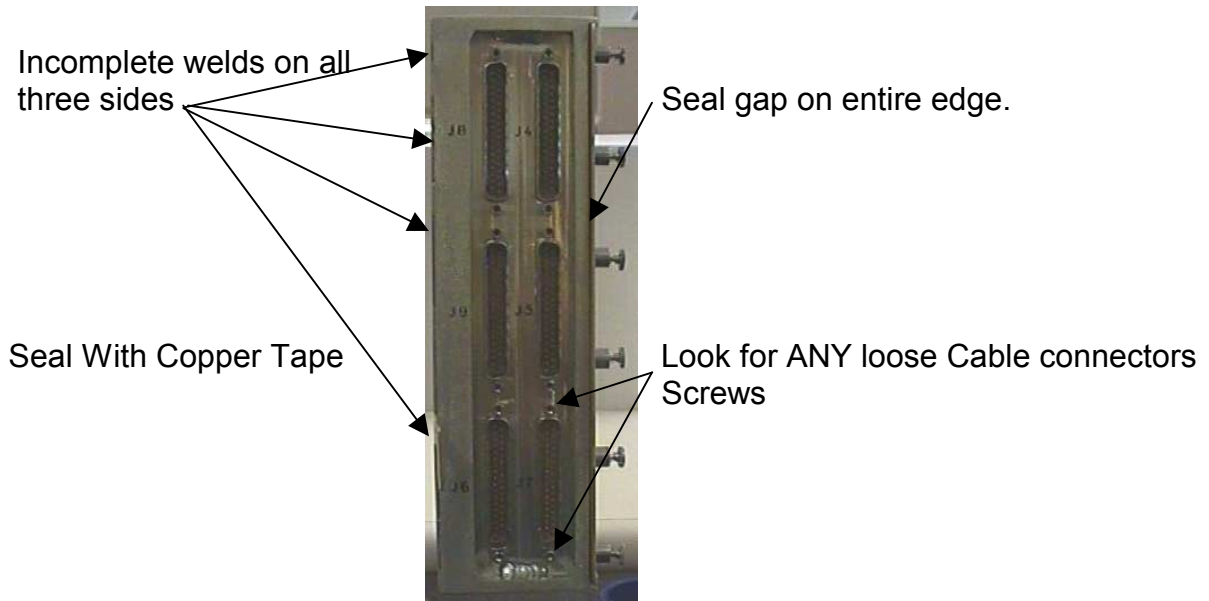
ILLUSTRATION 1-5

3. Inspect the bottom cover and sides of the SRI Unit. Welds may not be seamless and complete. Apply Tape to ANY suspicious leak source on the top bottom and sides of the SRI Unit.

**INCOMPLETE WELDS**

If you have a doubt about any crack or opening on the SRI seal it with copper tape.

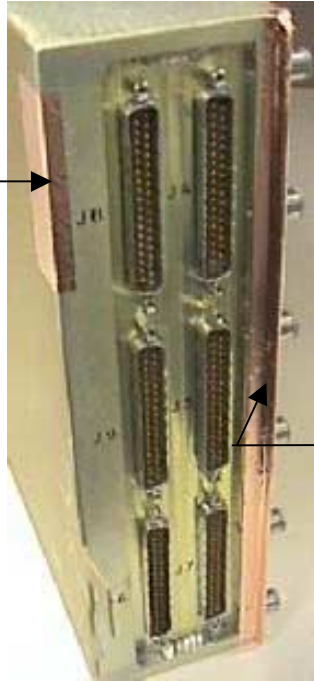
**Step 6**

Possible  
weld gap  
Sealed with  
copper tape
