The following boards are available as FRU's for the GRAM:

2- SYMPTOMS (CASE 1): POWER SUPPLY BOARD

2-1 Lockout Gradient Power

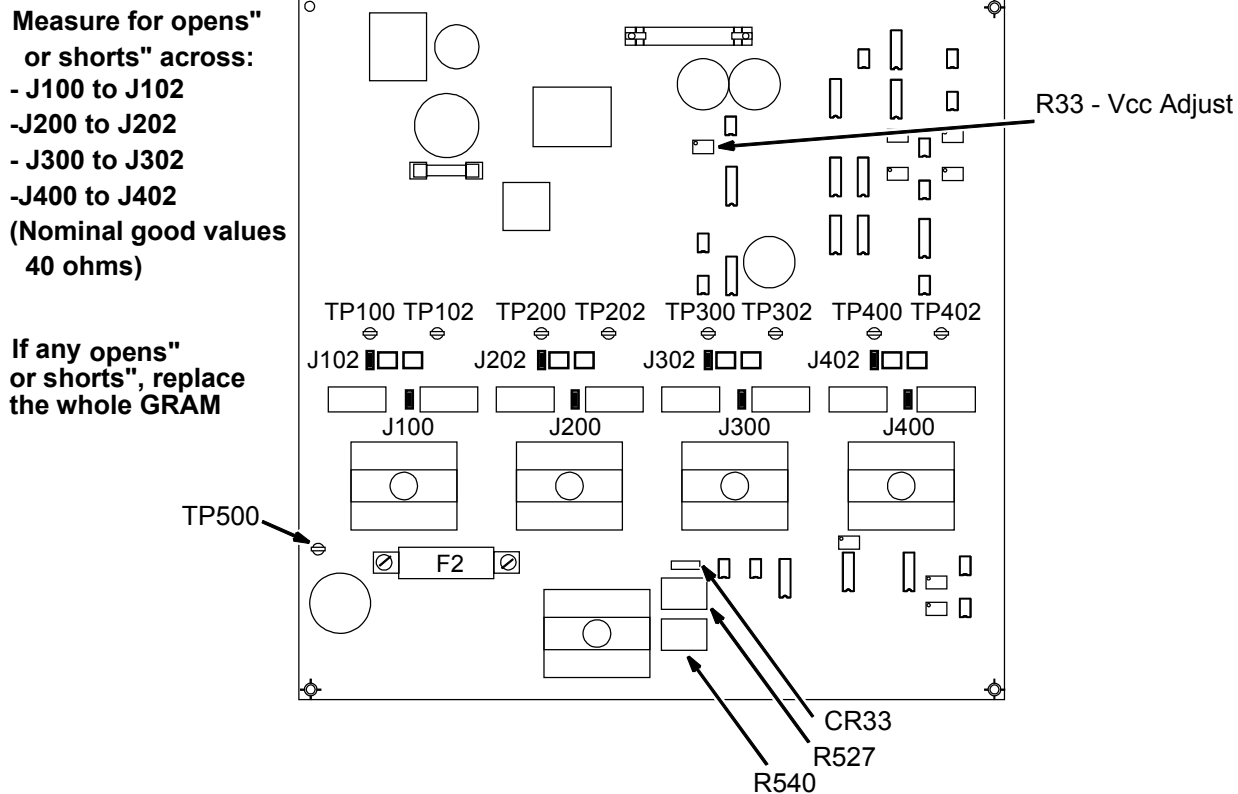
ILLUSTRATION 1
GRAM POWER SUPPLY BOARD

1. Power down GRAM and Gradient Cabinets.
2. Measure the internal resistor banks (power resistors) for “shorts” or “open circuits”. See illustration 1. If any “shorts” or “opens”, there is additional internal damage to the GRAM and you must replace the whole GRAM (#T3503AS).
3. If all 4 measurements are close to the nominal 40 ohms, order a replacement Power Supply Board (#T3503TG).

- F2 fuse on Power Supply Board is open
- If resistance across CR33 diode is not 100 ohms
- Either R527 or R540 are open

4. Order a replacement Power Supply Board (#T3503TG) if any of the following are true:

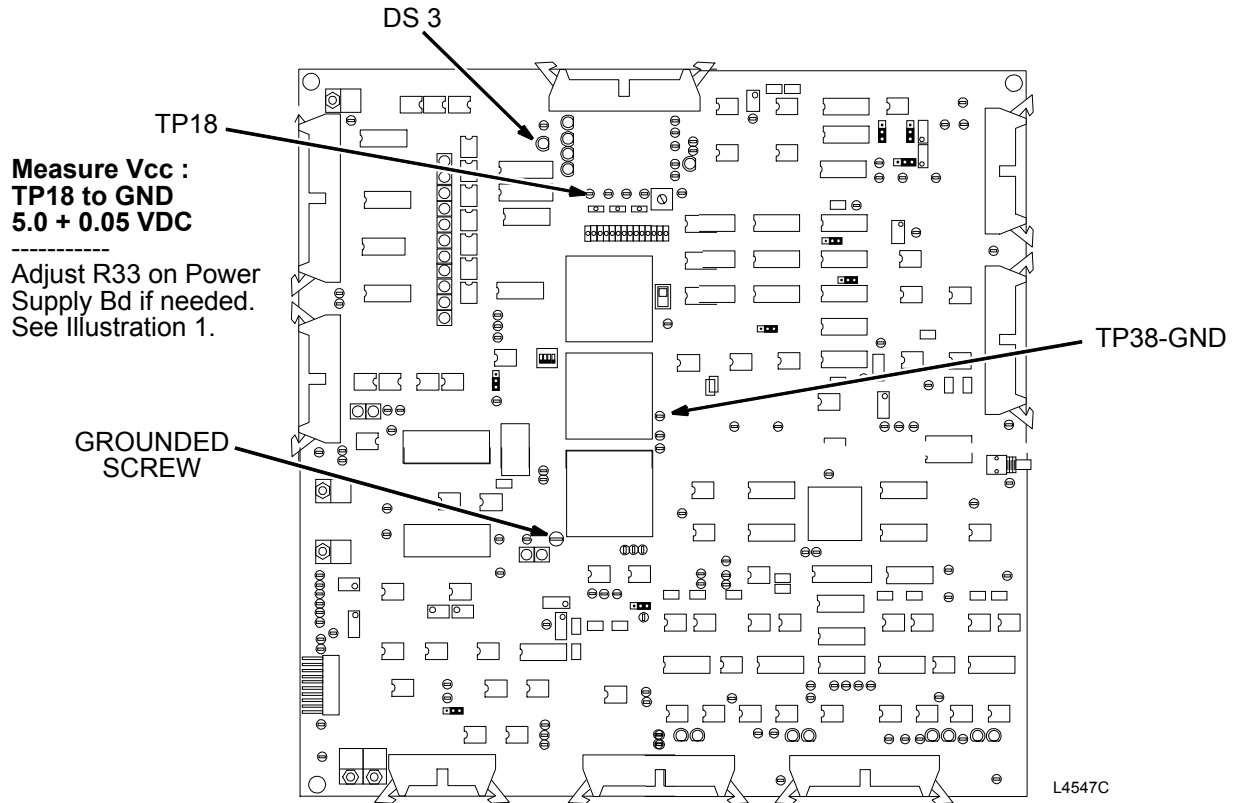
ILLUSTRATION 2
GRAM - CONTROL BOARD

There is one screw that provides a ground connection to the Control Board. This is the one screw without a fiber washer and is shown in illustration 2. Keep track of this one and make sure you put it back in the same location or the board will not function properly.

The following conditions are indicated on the GRAM or in the system error log: Overvoltage or Undervoltage, and GRAM Power Supply fault LED DS 3 on top left of Control Board is red. See illustration 2 for location of DS 3.

5. Install securing screws and then grounding screw into it's proper location as shown in Illustration 2.

8. Measure V_{CC} referring to illustration 2.

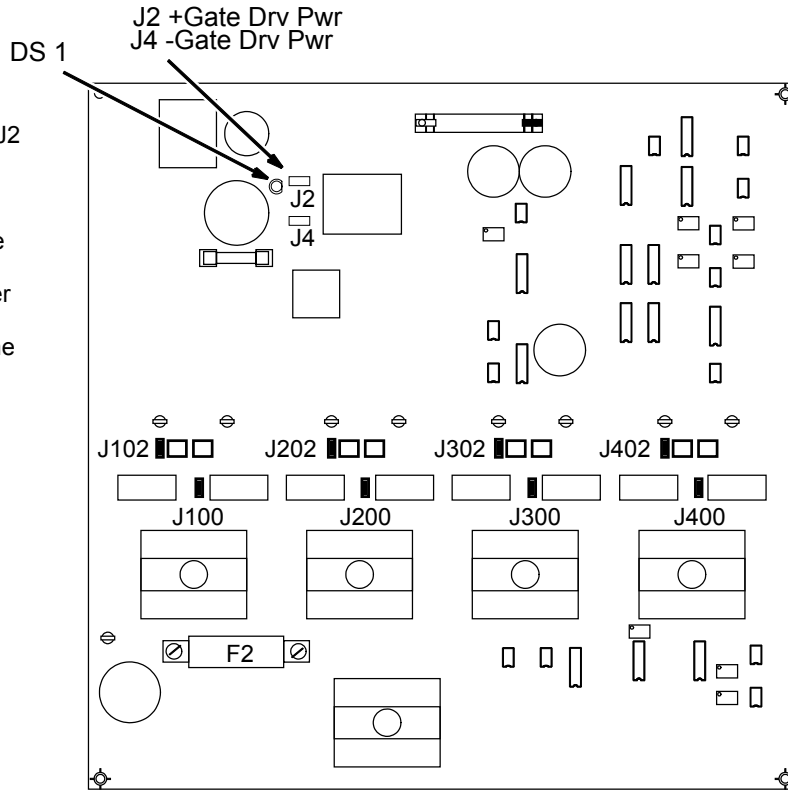
ILLUSTRATION 3
GRAM - POWER SUPPLY BOARD

If DS 1 is not lit, unplug cables from J2 & J4; if DS 1 lights plug cables back on one at a time. Then trace the cable that shorts out DS 1 to determine whether the left or right side Gate Driver Bd. is the bad one.

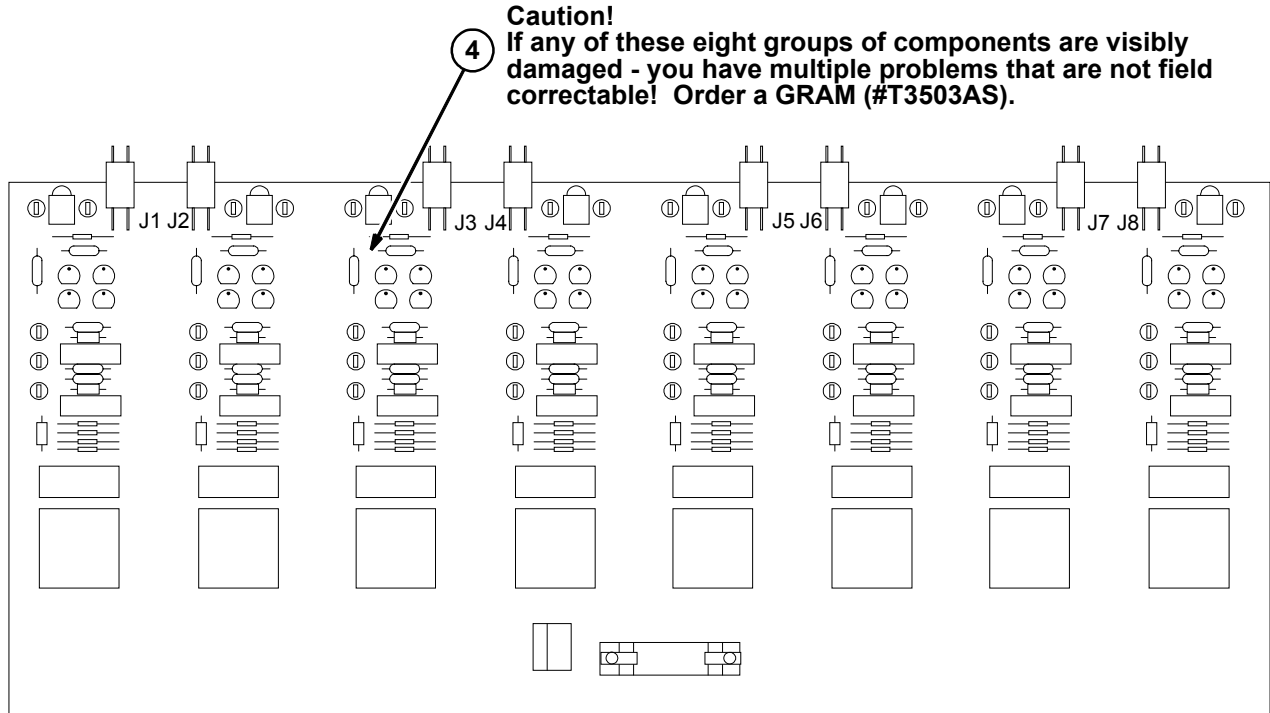
ILLUSTRATION 4
GRAM - GATE DRIVER BOARD

3. Power OFF the GRAM and Gradient Cabinets by following Section 2-1, Lockout Gradient Power.
4. Remove the side cover (right or left as determined in step 2.) to gain access to the bad Gate Driver Board.
5. Inspect the Gate Driver Board for burned resistors and transistors. See illustration 4.
6. If components shown in illustration 4 are intact, order a replacement Gate Driver Board (#T3503CE).
