APPENDIX I - INSPECT OXFORD CRYOSTAT AND CURRENT PROBE FOR ICE BUILDUP

I-1 INSPECT OXFORD CRYOSTAT AND CURRENT PROBE FOR ICE BUILDUP

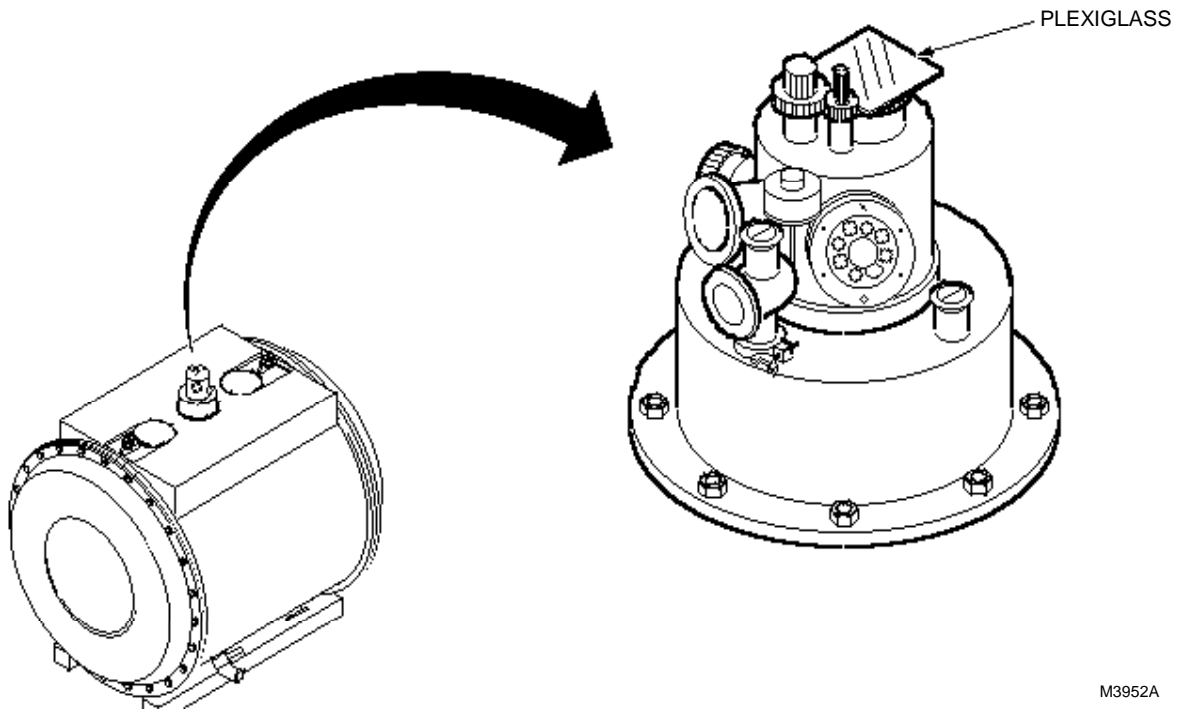
FILL AND PROBE PORTS
ILLUSTRATION I-1

1. Place a piece of plexiglass first over helium fill port and then over current probe port. See Illustration I-1.
2. Use flashlight to check for ice or frost build-up in ports. If no build-up is found, go to Step 14. Otherwise, go to Step 3.

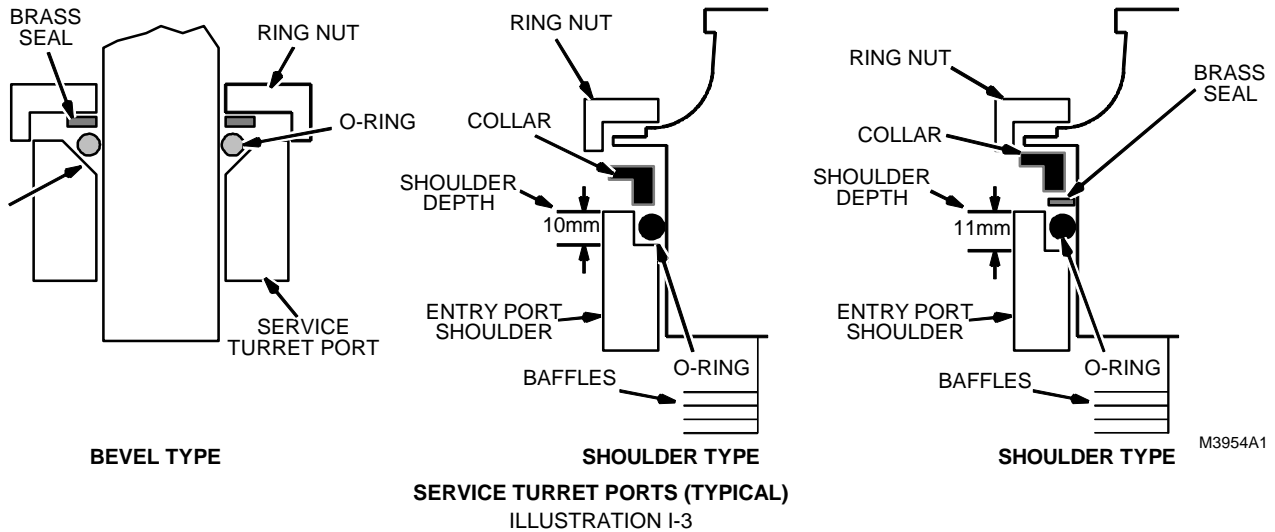
7. If ice was found, O-ring seals must be checked for proper size and assembly. Check that dewar O-rings have **not** been substituted for helium fill-port O-rings. Dewar O-rings are thinner and do **not** seal properly.
8. Remove locking collar of helium fill port. See Illustration I-3.

9. Check for compression of helium fill port O–ring. Depending on type, O–ring is compressed by either a brass flat washer or a brass bushing.
10. Some shoulder type systems also require a brass spacer below O–ring to insure O–ring is compressed. Otherwise, if O–ring is undersized, or if components are missing from baffle seal, flange will rest on lip of port, preventing O–ring compression and establishment of a proper seal.

11. Replace broken or undersized O–rings.
12. Replacement brass flat washer, flange or ring nut may be ordered from Oxford (Call (201) 541-1300 and ask for parts department).
