This document is intended to be used by experienced Manufacturing Technicians, Field Engineers and their support personnel as a guide to diagnosis of problems detected by System Performance Test (SPT).

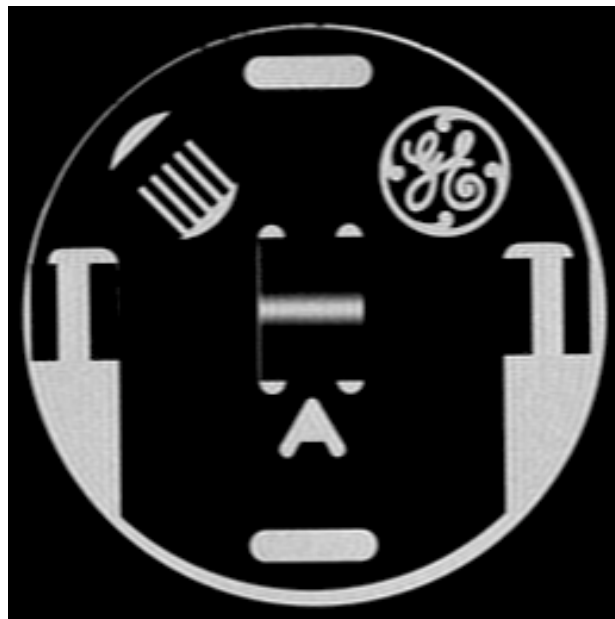
- First time run of SPT after installing new hardware in a bay using config file values restored from previous bay load.
- Running SPT on an uncalibrated system will cause this failure. SPT is only intended to be used to "touch up" Grad Cal calibration.
- Faulty DQA-III phantom (usually Y axis). Compare thin outside line at top of phantom to wide outside line at bottom of phantom. Illustration L1 shows that the DQA-III phantom internal structures are improperly centered in the phantom shell.

ILLUSTRATION L1  
IMPROPERLY CENTERED DQA-III INTERNAL STRUCTURES
