Diagnosing SPT Problems

Introduction

This document is intended to be used by experienced Manufacturing Technicians, Field Engineers and their support personnel as a guide to diagnosis of problems detected by System Performance Test (SPT). For many of the test parameters, the approach to isolating a failure reported by SPT will be similar to that followed for TLT, so your experience with TLT will still be useful.

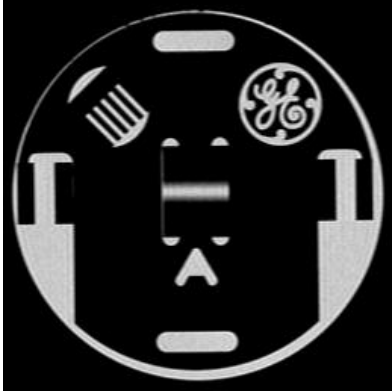
Faulty DQA-III phantom (usually Y axis). In the following illustration, compare thin outside line at top of phantom to wide outside line at bottom. The illustration shows that phantom internals are improperly centered in the phantom shell.

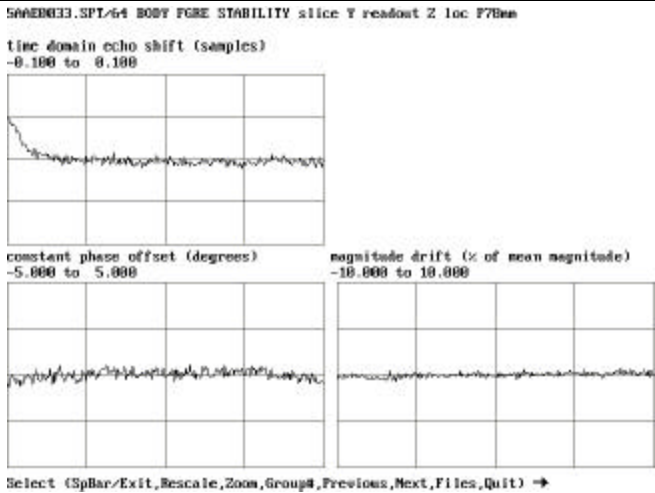
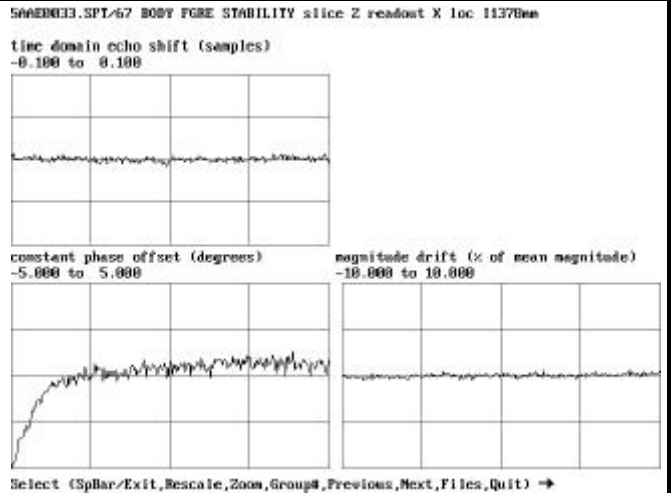
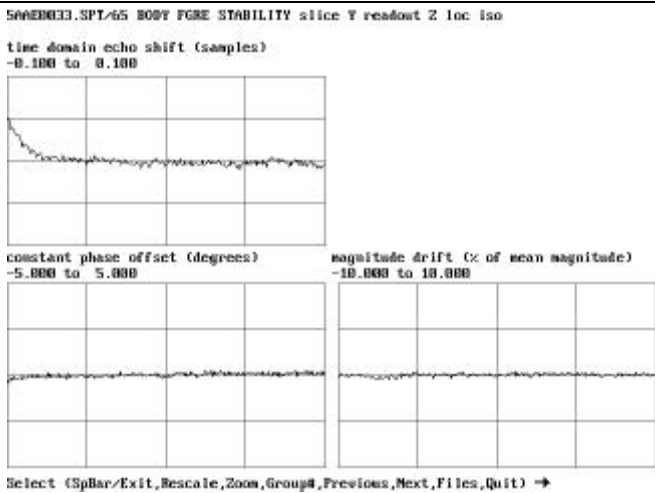
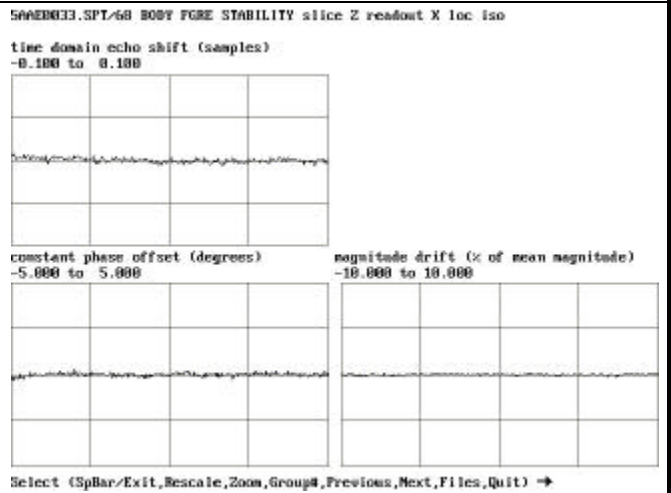
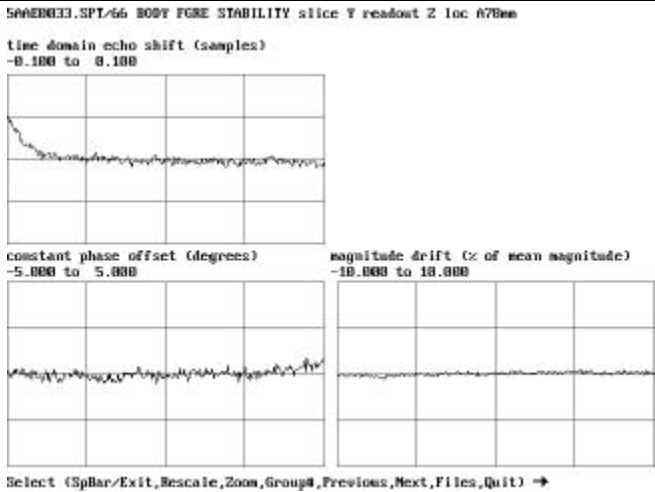
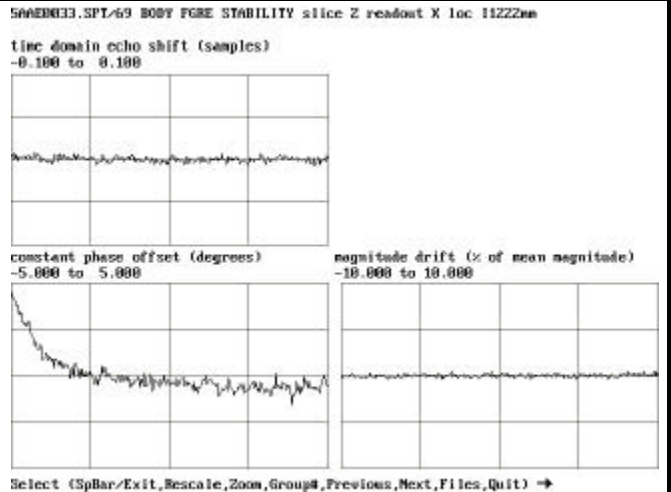
FGRE Stability Example -- Inadequately compensated long time constant eddy currents.

When Z is used for readout, effect on echo shift is not dependent on slice location.

When Z is used for slice select, there is no effect at isocenter, but at opposed off-isocenter locations, the effect is present and opposite in polarity.

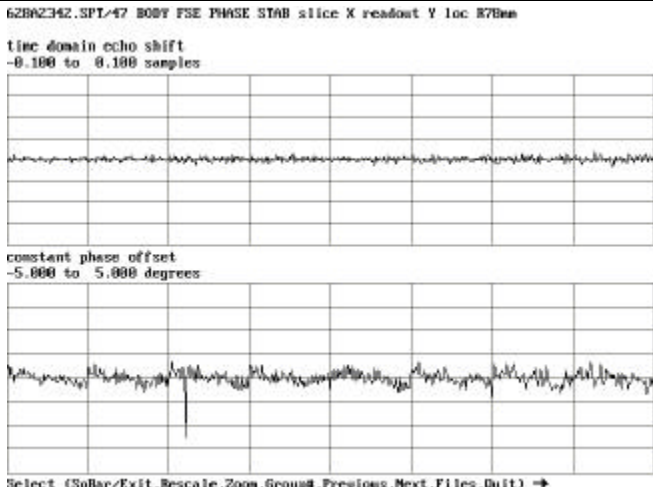
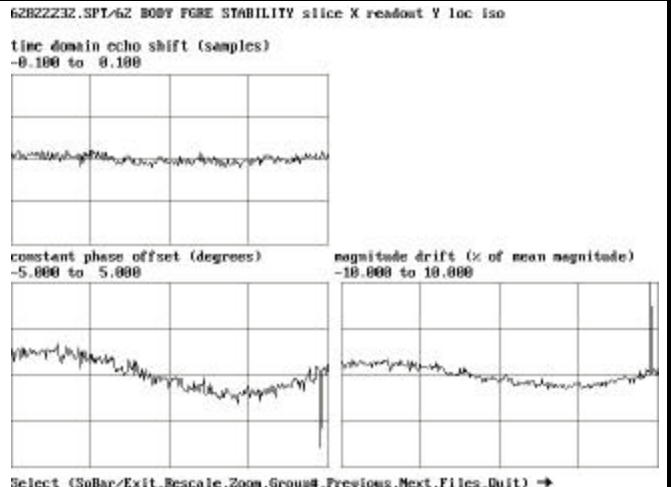
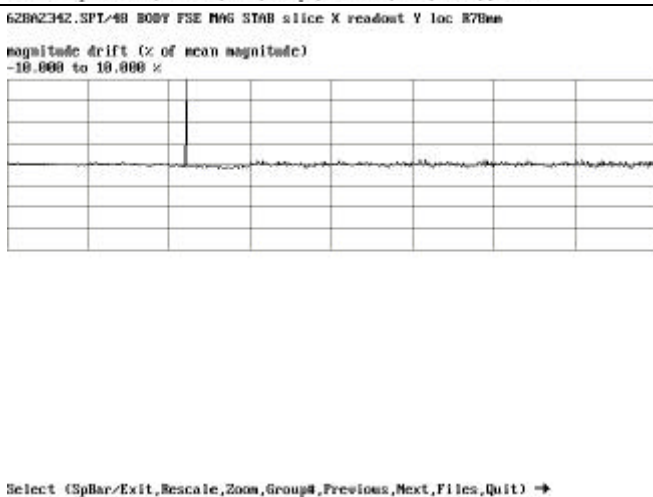
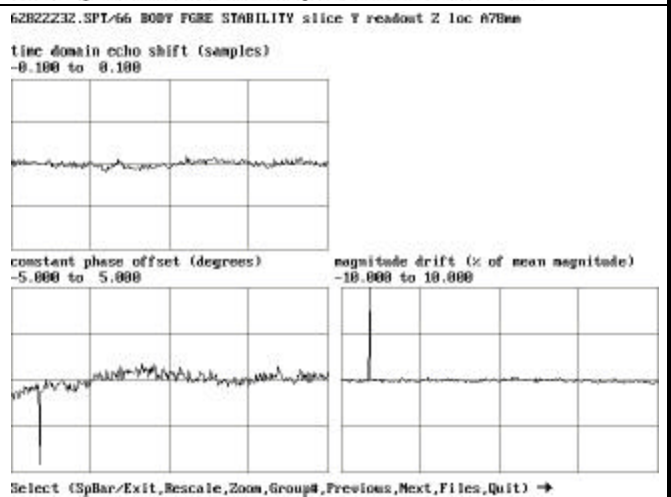
FSE & FGRE Stability Example -- Magnitude and constant phase spikes caused by body preamplifier.

It is *very* important to note that the spikes do *not* propagate in the echo train after the initial event. This means that the event occurred during *receive* time since the "physics" was *not* affected. Therefore, the problem *must be in the receive chain*.

It is not possible to determine if spikes in FGRE stability plots were caused by an event during transmit time or receive time.

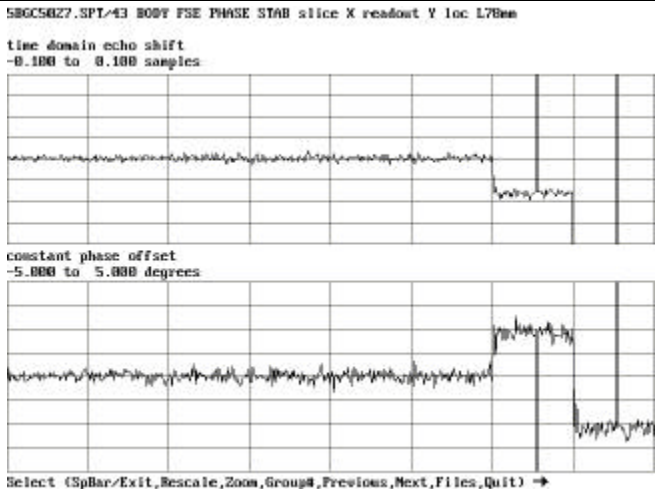
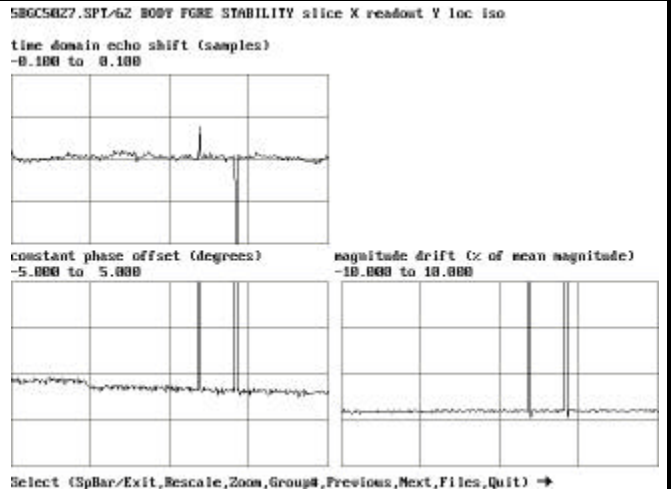
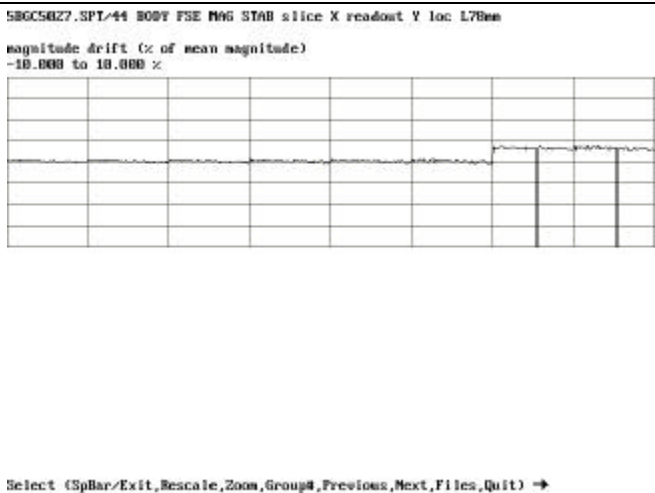
FSE & FGRE Stability Example -- Spikes caused by defective IPG.

It is *very* important to note that the spikes *do propagate* in the echo train after the initial event. This means that the event occurred during transmit time since the "physics" *was* affected. The peak-to-peak magnitude error was *100.3 %* which suggests that entire views of data were missing.

It is not possible to determine if spikes in FGRE stability plots were caused by an event during transmit time or receive time.

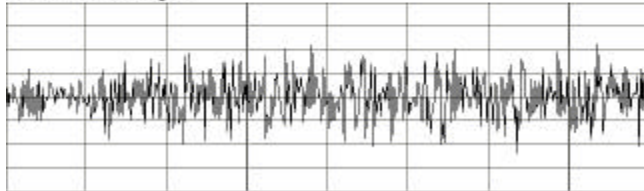
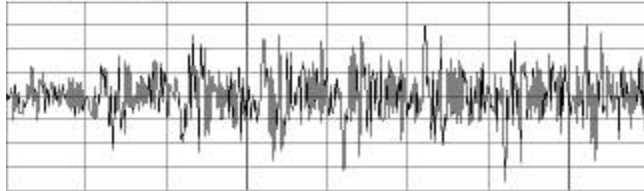
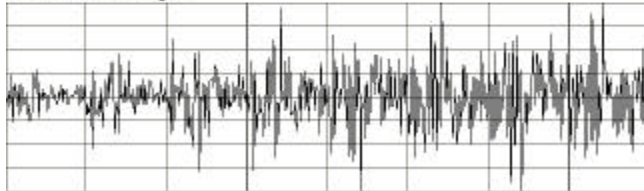
FSE Stability Example -- High vibration caused by rotating machinery on floor above magnet.

Phase plots from FSE stability test. Results are similar on all planes. Coronal plane is shown since it was worst.

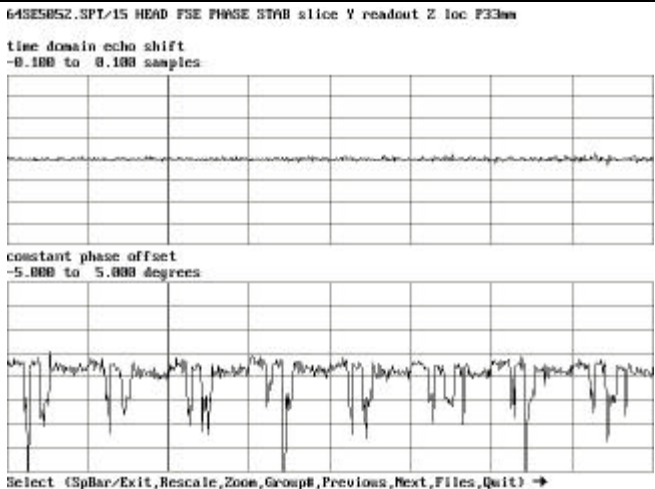
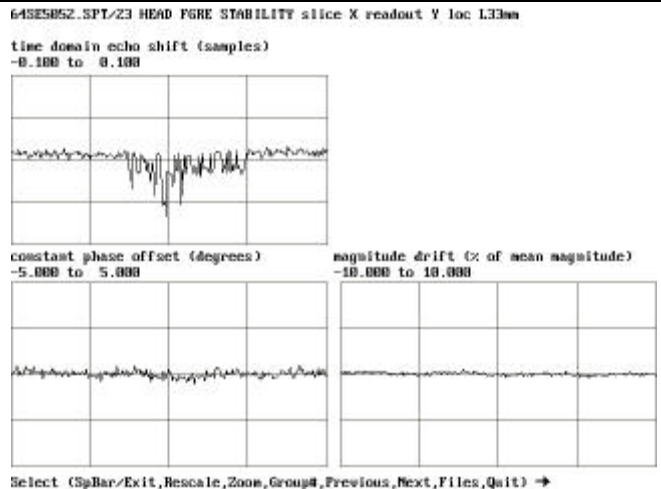
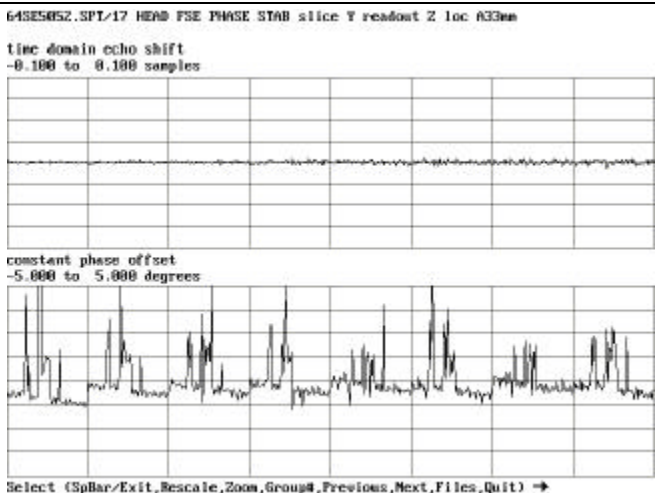
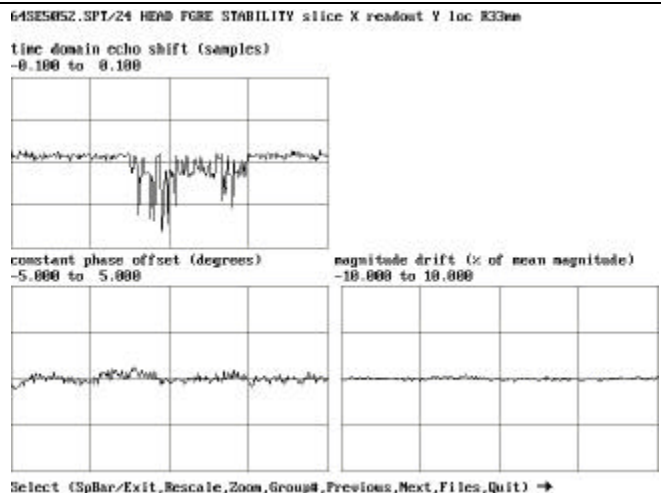
FSE & FGRE Stability Example -- Failures caused by defective Y axis GRAM.

It is *very* important to note that the spikes *do propagate* in the echo train after the initial event. This means that the event occurred during transmit time since the "physics" *was* affected. Also notice that the polarity of the phase disturbance is inverted on opposite sides of isocenter. Since the events causing the instability occurred during transmit time and the phase error switches polarity on opposite sides of isocenter, the problem is virtually certain to be caused by the gradient driver hardware used for slice selection - in this case the Y axis GRAM was beginning to fail.

It is not possible to determine if spikes in FGRE stability plots were caused by an event during transmit time or receive time. However, since the primary effect is on time domain echo shift, it is highly likely that the gradient driver hardware used for readout is at fault - in this case the Y axis GRAM was beginning to fail.

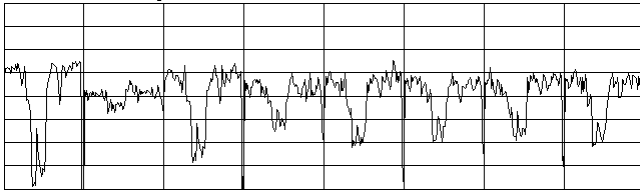
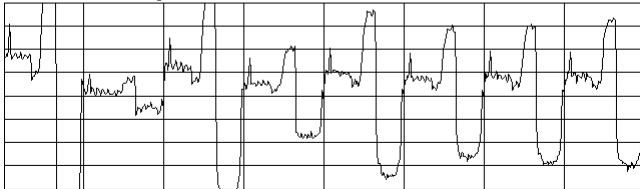
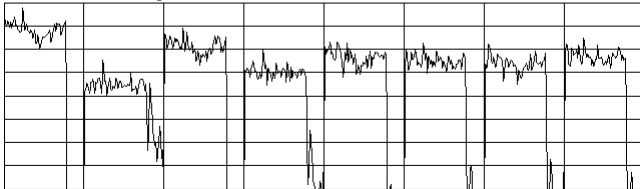
FSE Example -- Failures caused by defective Erbtec RF amplifier.

The FSE stability plots below demonstrate the effects of a defective RF amplifier. Note that time domain echo shift is hardly affected at all and that *both* constant phase and magnitude *are* affected significantly. Also note that disturbances propagate from echo to echo in the echo train, indicating a transmit-time failure. The first slice from each axis is shown but in the original file all body FSE results were similarly affected. FSE stability results were consistently excellent after the RF amplifier was replaced.

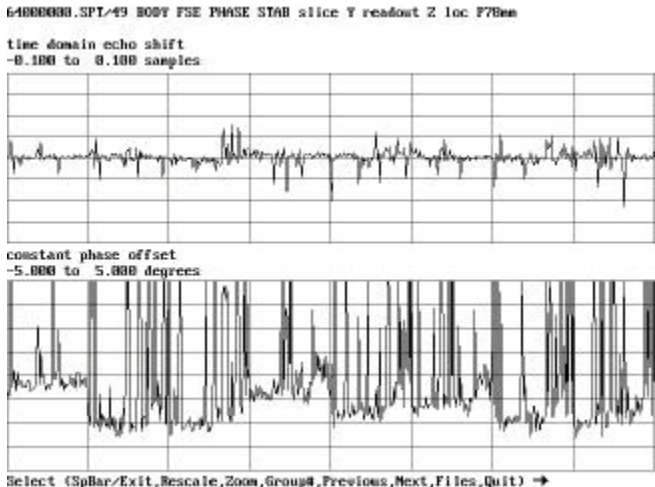
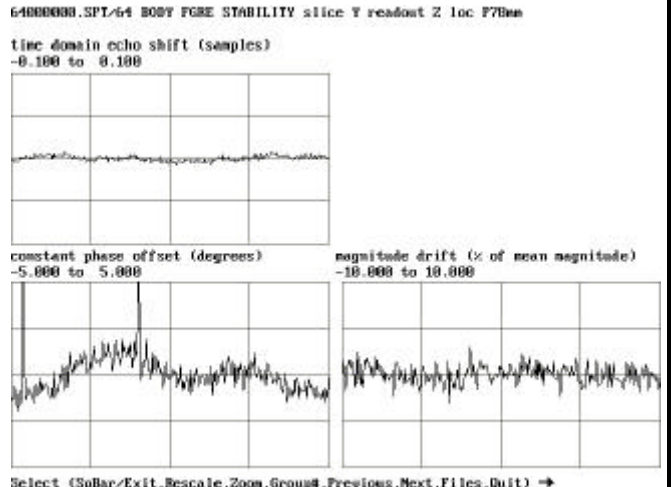
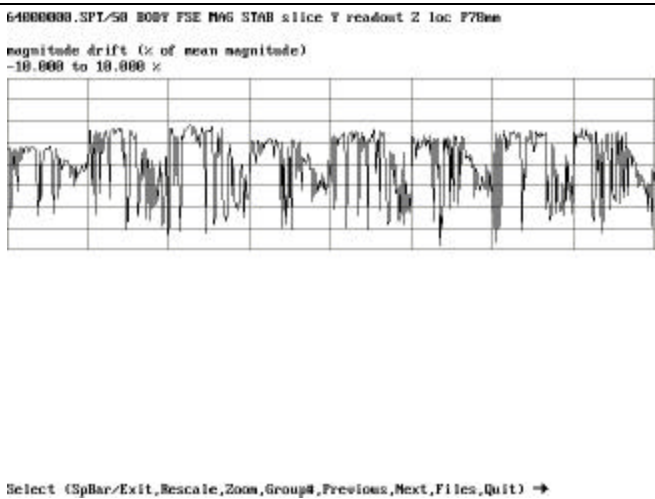
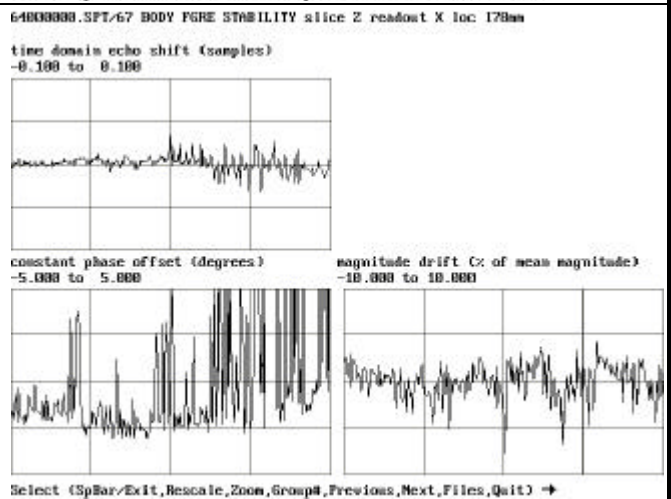
FSE & FGRE Stability Example (5.4 System) -- Failures caused by loose dynamic disable box RF connectors on the body coil.

FSE stability results are very bad on all axes. Constant phase error *does not* change polarity with slice location. Spikes *do not* propagate through the echo train. These symptoms suggest a vibration induced RF receive time problem.

In the FGRE stability case, the worst instability was seen when the Z axis was used for slice select but again slice location had no impact on the results. When viewed in the context of the FSE stability results, FGRE results support the loose RF connection hypothesis.
