## 1- SCAN ROOM INTERFACE (SRI) TROUBLESHOOTING

The Scan Room Interface Unit can be a source for intermittent and continuous RF leaks from the frequencies generated by the controllers and Integrated circuits within it. It is necessary to open the cover to look at diagnostic LED and service the SRI. Occasionally, it may be necessary to remove the cover to inspect the inside, or reattach fiber optic cables that may have come loose.

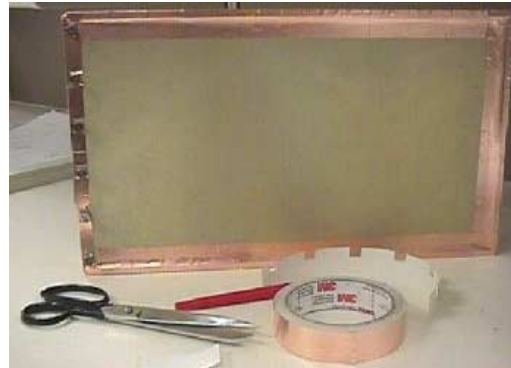
**SEALED SRI MODULE**  
1-7

Copper Tape wrapped under edge.

Use a pencil eraser to rub down the tape to insure the copper tape has made a good bond. Avoid any wrinkles. They may cause RF leaks.

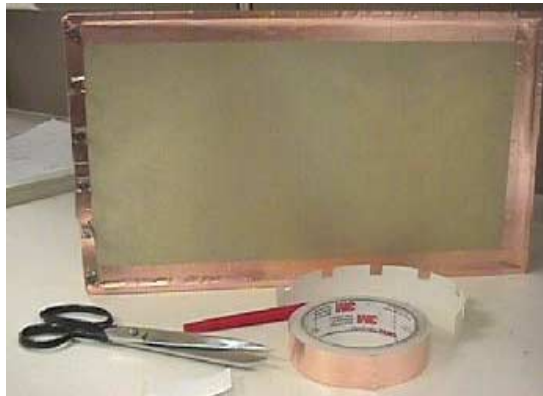
**COPPER TAPE APPLIED**  
ILLUSTRATION 1-10

Completed and properly sealed Scan Room Interface Unit.
