SERVICE NOTE

Signa[®] Service Tools

SN 67031

ANALYZING HSS (HIGH SPEED STABILITY) RESULTS

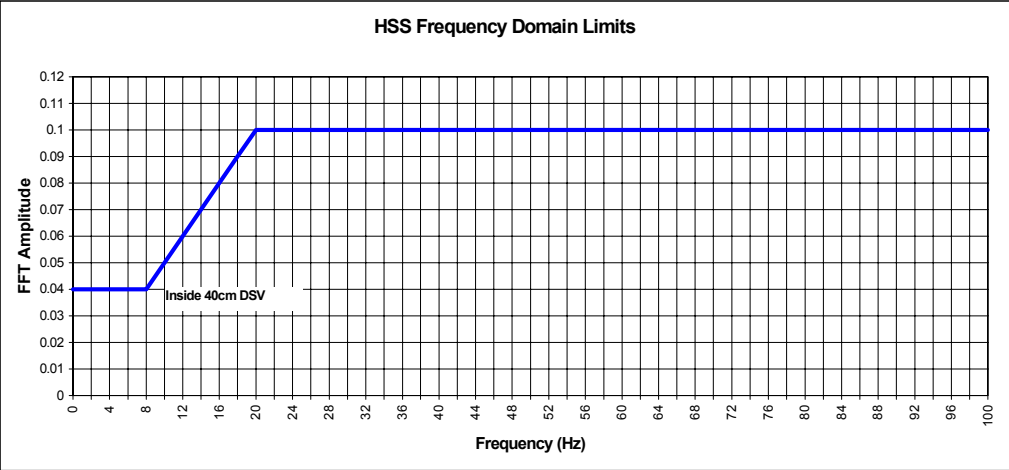
HSS FREQUENCY DOMAIN SPECS.
ILLUSTRATION 5

The Spec for the Amplitude of a peak value is dependent upon frequency using the following Chart:
