GE Medical Systems

**Direction 2252520
Revision 0**

Signa® Gradient Isolation Kit Installation

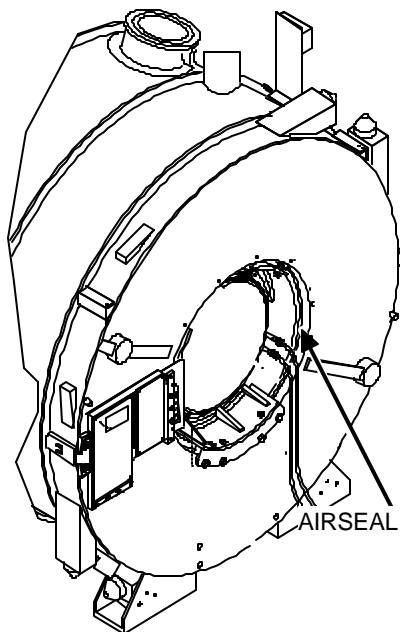
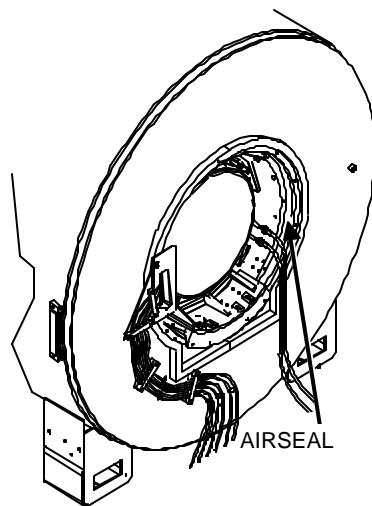
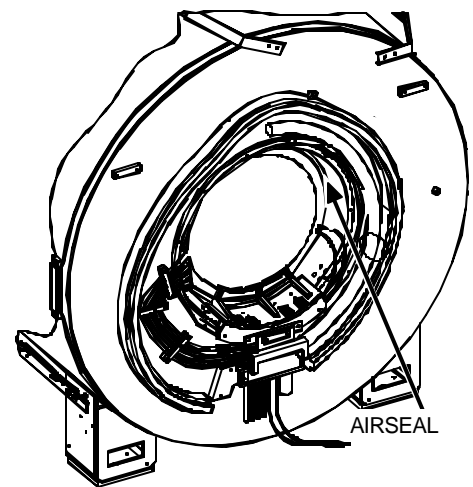
**LCC MAGNET
REMOVE AIRSEAL
ILLUSTRATION 3-1**

1. Remove air seal from the BRM/BRM-D/CRM. See Illustration 3-1.

CX MAGNET

WIDEOPEN ENCLOSURE

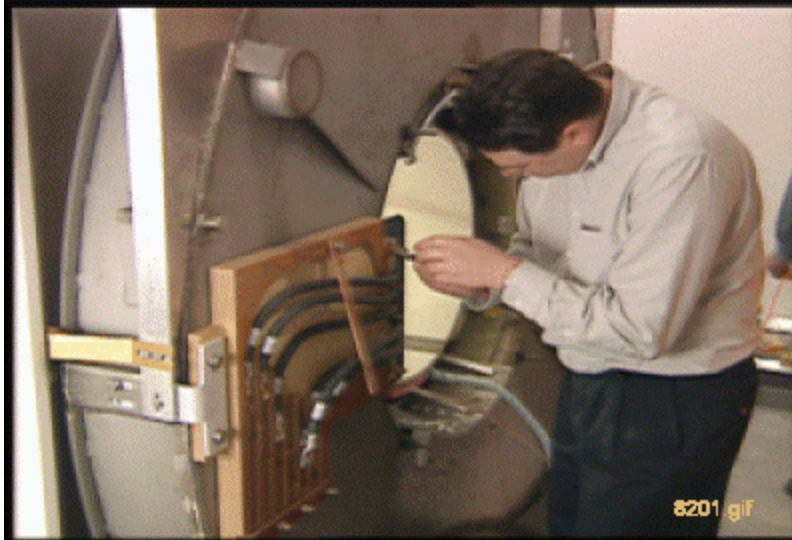
ILLUSTRATION 3-2

2. Remove the Terminal Block or cable bracket located on the rear flange of the magnet. See Illustration 3-2. (The Terminal Block is not used with the BRM-D and MR/i & CV/i WideOpen systems)

REMOVE TERMINAL BLOCK

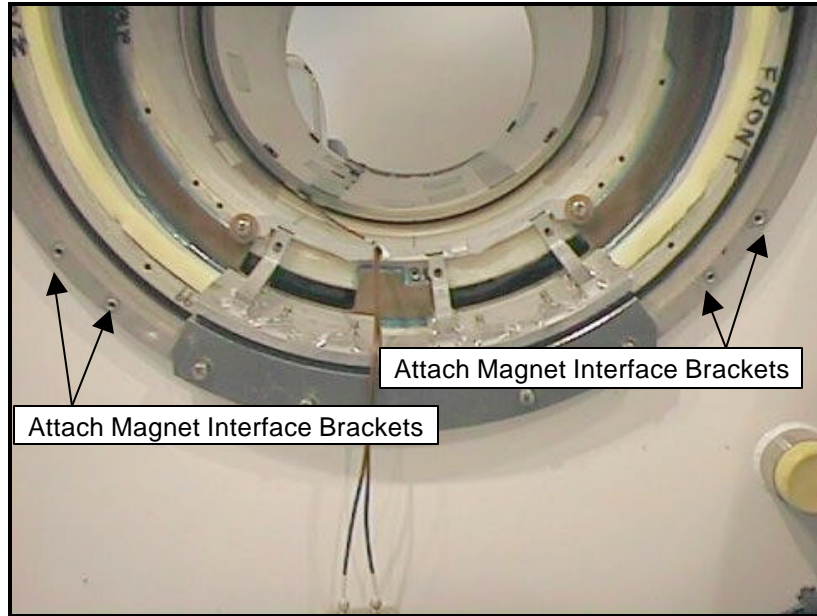
PLACEMENT OF MAGNET INTERFACE BRACKETS
ILLUSTRATION 3-3

- 8. Install the left and right magnet interface brackets on the end flange using the 4 – 35 mm screws. See Illustration 3-3 and Illustration 3-4.

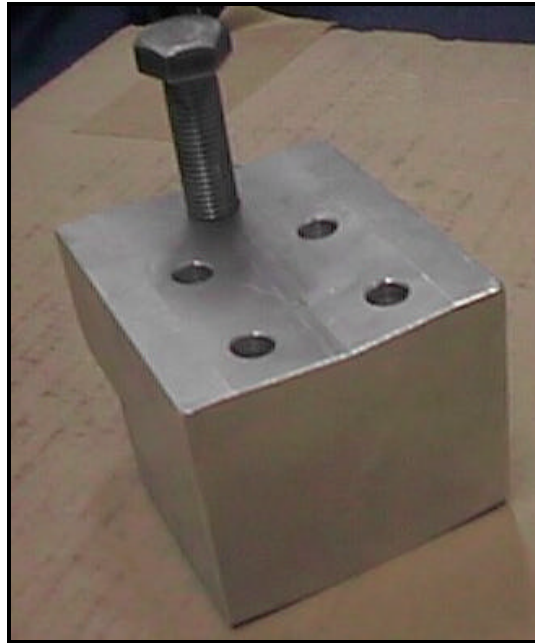
ILLUSTRATION 3-5

- 9. Insert the bolts into the Coil Interface Brackets. See Illustration 3-5.

BOLT PLACED IN COIL INTERFACE BRACKET

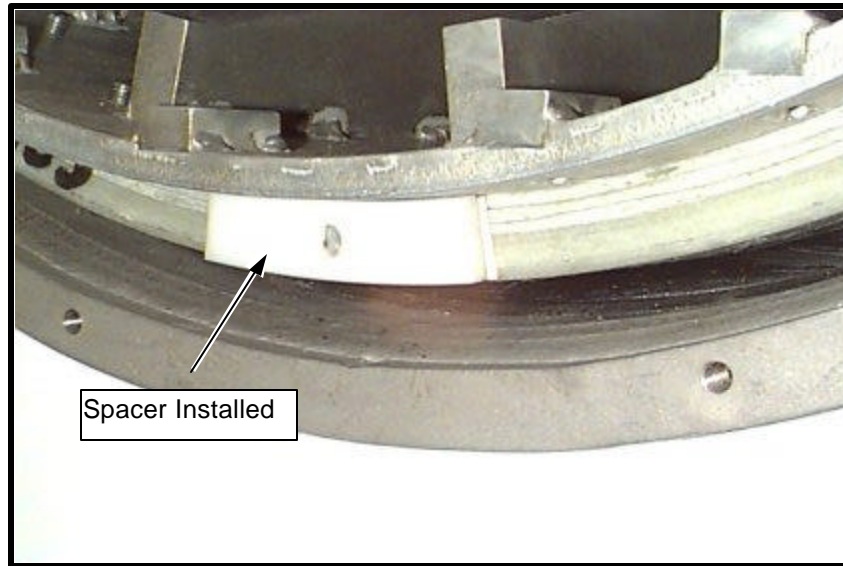
GRADIENT COIL LIFTED
ILLUSTRATION 3-6

12. Lift patient end of the gradient by tightening the bolt in the Coil Interface Bracket until the aluminum support brackets separate by at least 4 mm (1/8 inch).
13. Remove lower support bracket from the patient end of the cryostat.
14. Install the fixed spacer (P/N 2238908-4 10 mm for CRM, P/N 2238907-2 28 mm for BRM) as shown in Illustration 3-6. Use the M10x25 nylon cheese head screws for BRM and CRM. Screw head must be either level or inside the spacer hole. See Illustration 3-6.
15. Install rubber pads on brackets.

Do not use duct tape to install rubber pads. Duct tape was only used in picture to show rubber pads on brackets.

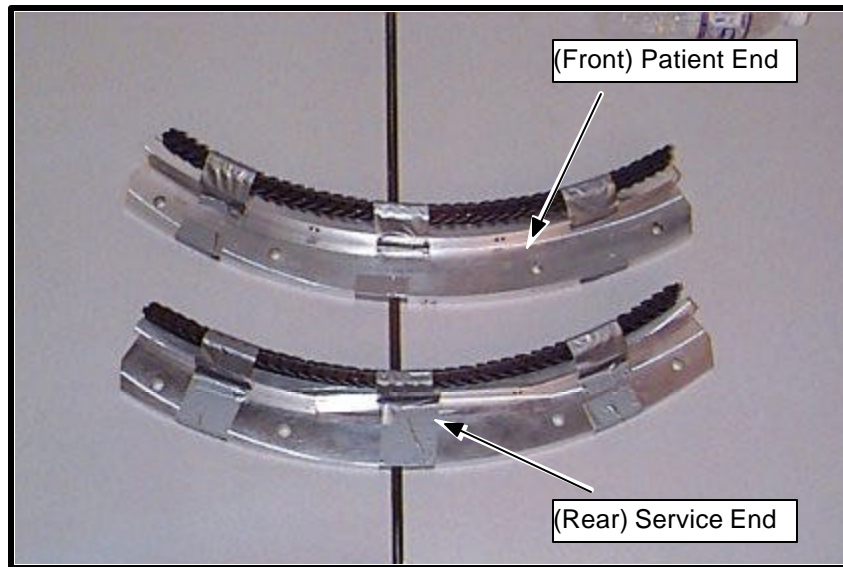
SUPPORT BRACKETS
ILLUSTRATION 3-7

16. Install (front) patient end bracket. Use #242 blue loctite on the 4 M10 screws and secure to the end flange. See Illustration 3-7.
- For CRM: bracket is installed with lip facing out. See Illustration 3-8
 - For BRM: bracket is installed with lip under the existing bracket.

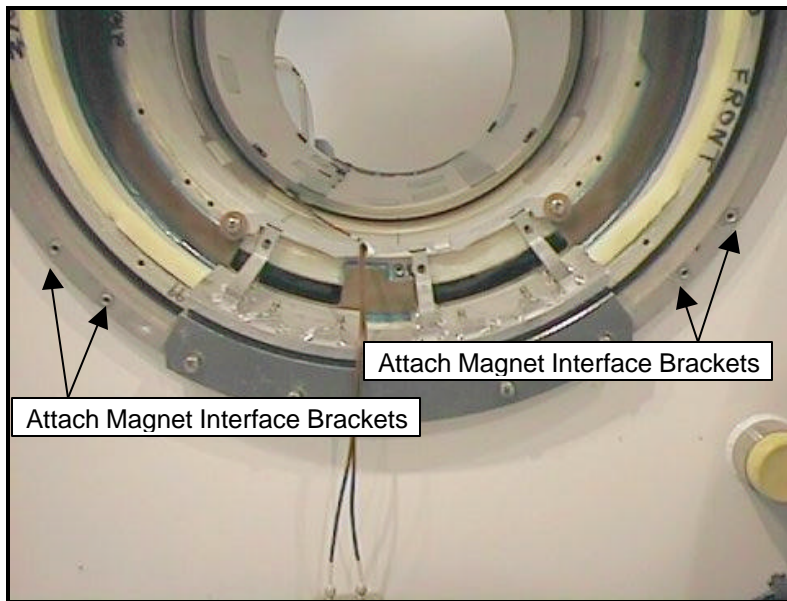
PLACEMENT OF MAGNET INTERFACE BRACKETS
ILLUSTRATION 4-1

1. Install the left and right magnet interface brackets on the end flange using the 4 – 35 mm screws. See Illustration 4-1 and Illustration 4-2.

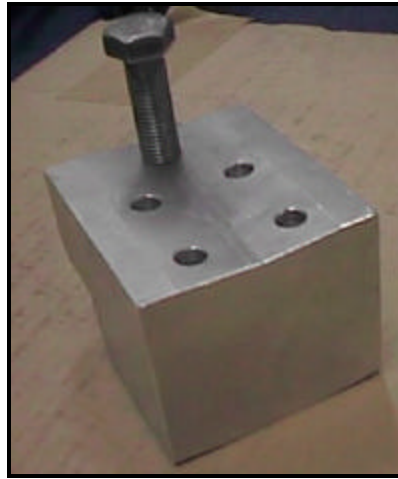
BOLT PLACED IN COIL INTERFACE BRACKET
ILLUSTRATION 4-3

2. Insert the bolts into the Coil Interface Brackets. See Illustration 4-3.

3. Remove the rear bottom RF Coil adjusting blocks to insure proper fit of the Coil Interface Bracket.
4. Attach the Coil Interface Bracket on the gradient coil using the 8 – 100 mm screws on both the right and left magnet interface brackets. See Illustration 4-3.
5. Lift service end of the gradient by tightening the bolt in the Coil Interface Bracket until the aluminum support brackets separate by at least 4 mm (1/8 inch).
6. Remove lower support bracket from the service end of the cryostat.
7. Select a shim combination so the gap between the outermost shim and the support bracket is not more than 1.5mm and not less than 0.6mm. See Illustration 4-4.

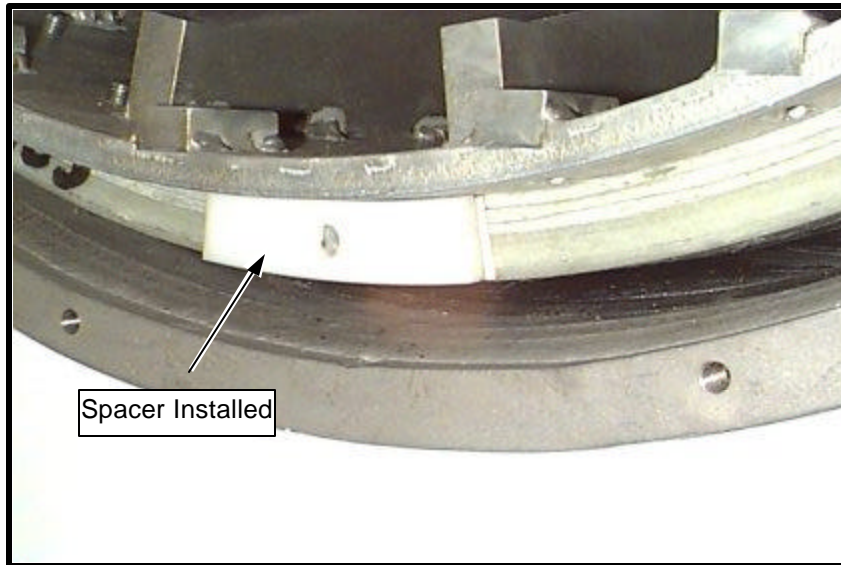
GRADIENT COIL LIFTED
ILLUSTRATION 4-5

- 8. Install the fixed spacer (the 16 mm [P/N 2238907] spacer and shims are required for the BRM) as shown in Illustration 4-5. Use the M10x25 nylon cheese head screws for BRM and CRM. Screw head must be either level or inside the spacer hole.

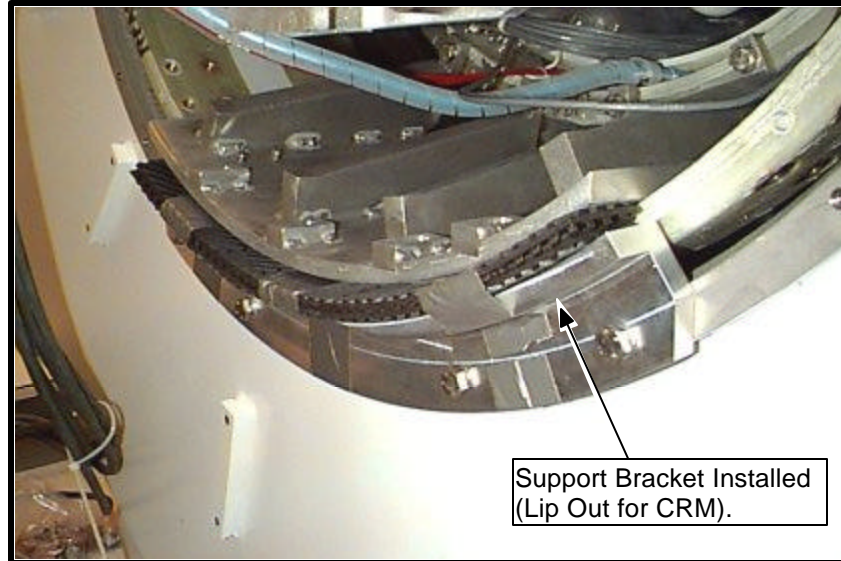
ILLUSTRATION 4-7

9. Install (rear) service end bracket. Use #242 blue loctite on the 4 –M10 screws and secure to the end flange.
 - For CRM: bracket is installed with lip facing out. See Illustration 4-7
 - For BRM: bracket is installed with lip under the existing bracket.

SUPPORT BRACKET INSTALLED

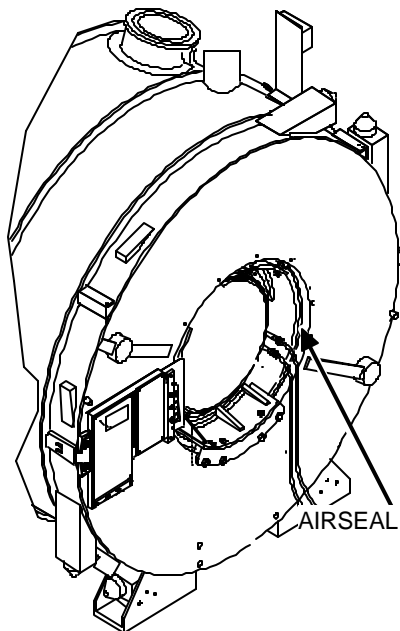
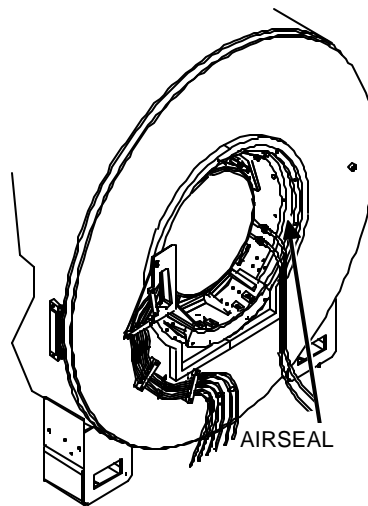
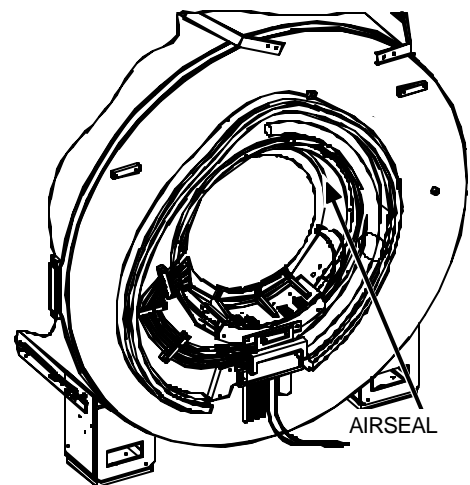
**LCC MAGNET
REPLACE AIRSEAL
ILLUSTRATION 5-1**

1. Replace the rear bottom RF Coil adjusting blocks.
2. Replace the 4 (four) M10 screws between aluminum support brackets on the patient end and service end of the magnet.
3. Replace the poron seal gray pads to cover the 8 bolt holes where the Coil Interface Bracket was installed.
4. Replace the top bolts and fiber washers from the gradient coil.
5. Replace the BRM/BRM-D/CRM radial support blocks and support BRM/BRM-D/CRM Assembly.
6. Replace the Terminal Block or cable bracket located on the rear flange of the magnet. (The Terminal Block is not used with the BRM-D and MR/i & CV/i WideOpen systems.)
7. Replace Open Foam Caulking Strip (2179397-3) and all Air Seals. See Illustration 5-1.
8. Confirm Gradient cooling air is not leaking.

CX MAGNET

WIDEPEN ENCLOSURE
