### SECTION 1 – OVERVIEW OF 8.3 POST M5 PATCH 01

Signa Lx 8.3 Post M5 Patch 01 Software CD-ROM 2274462-2 Rev 0.

### SECTION 3 - PATCH INSTALLATION INSTRUCTIONS

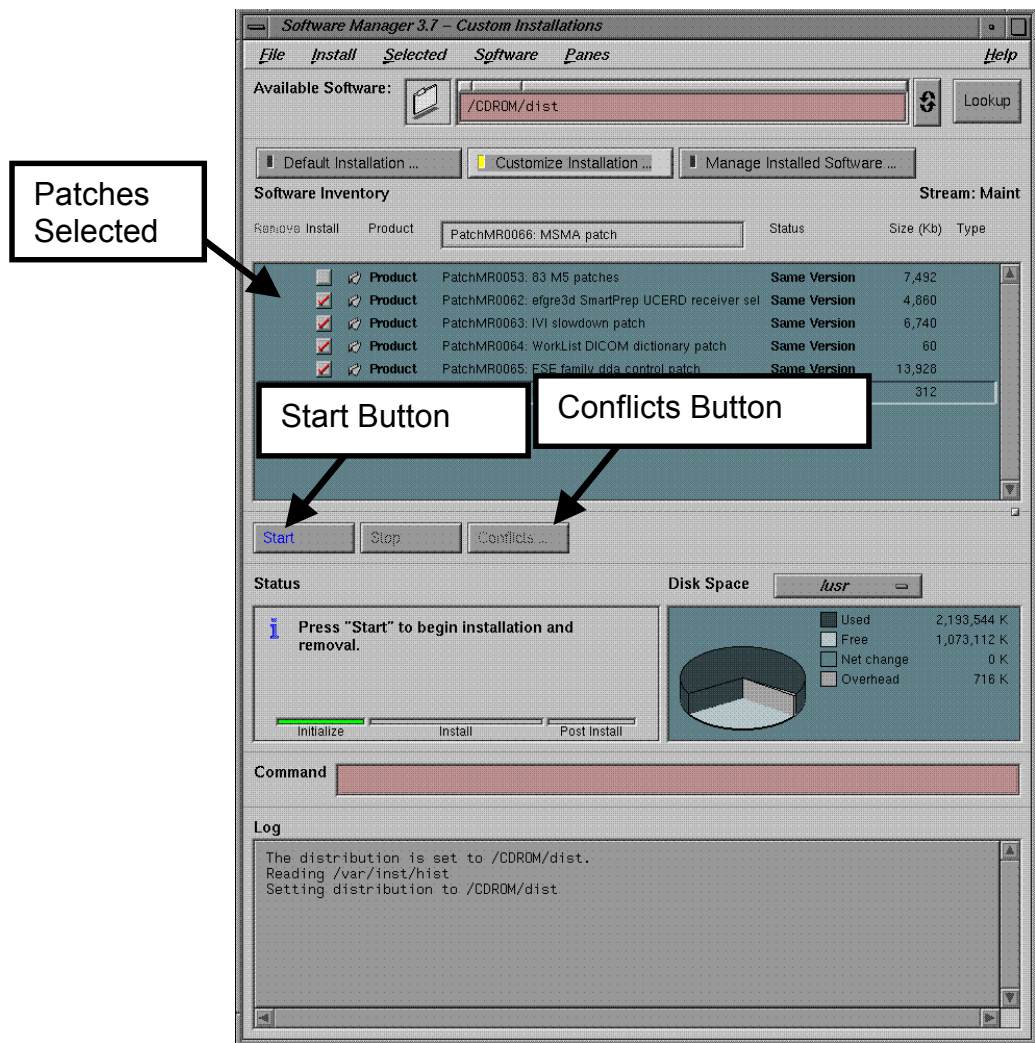
LOADING THE PATCH  
ILLUSTRATION 2

8. All available patches should be visible at this time in the selection window. Any patches that apply to your system and are not loaded will be selected (check marked). It is recommended that all selected patches be loaded, but you can deselect any by clicking the little gray check box at the left of the patch description. See Illustration 2. One of two things will happen next:

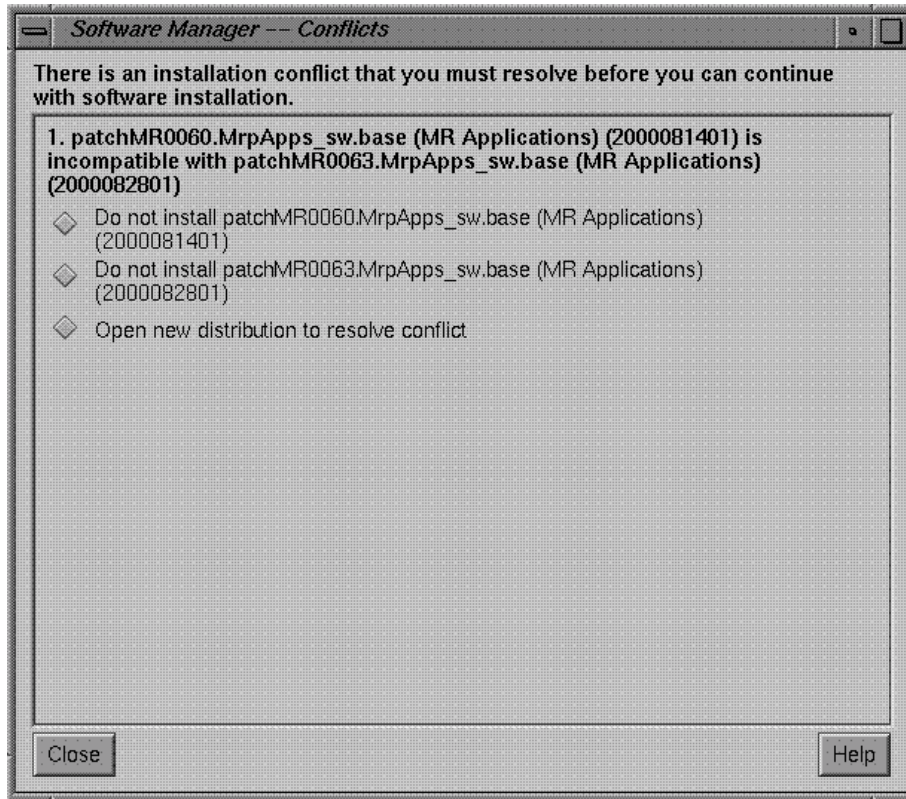
**WARNING MESSAGE THAT THE SOFTWARE LOADED WILL NOT NEED THE PATCH**  
ILLUSTRATION 3

- b. After the patch is selected, if there is a problem, the **[Conflicts]** button will activate, (the letters in "Conflicts" change colors or shades). If this happens, this indicates that your system does not need this patch and the indicated patch will not be loaded. Push the **[Conflicts]** to view the error if desired, see Illustration 3 for an example error message. Choose **[Close]** to continue from the Conflicts window.

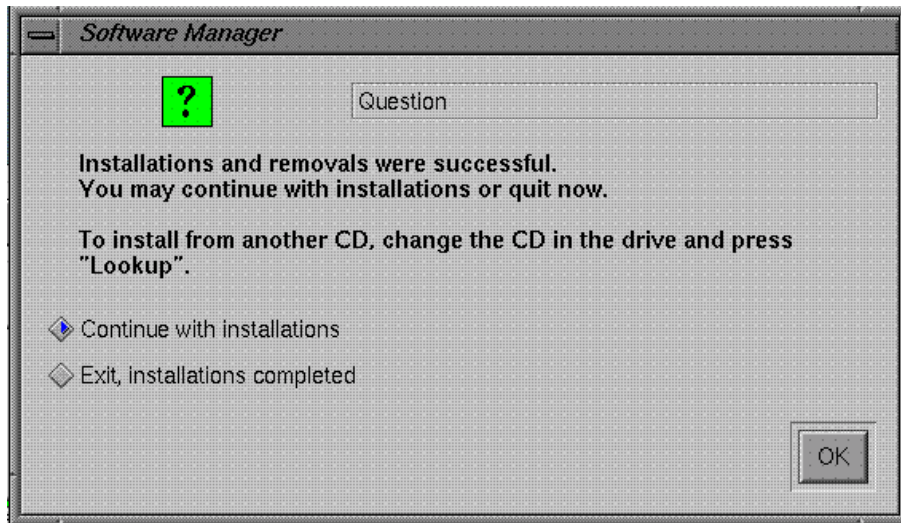
**INSTALLATION DECISION WINDOW**  
ILLUSTRATION 4

9. After installation, select **Exit, Installations completed** checkbox, then select **[OK]**. See Illustration 4.
