2 – 1.5T ANALOGIC RF AMPLIFIER TROUBLESHOOTING FLOWCHART

2-1 Main Body And RF Output Troubleshooting

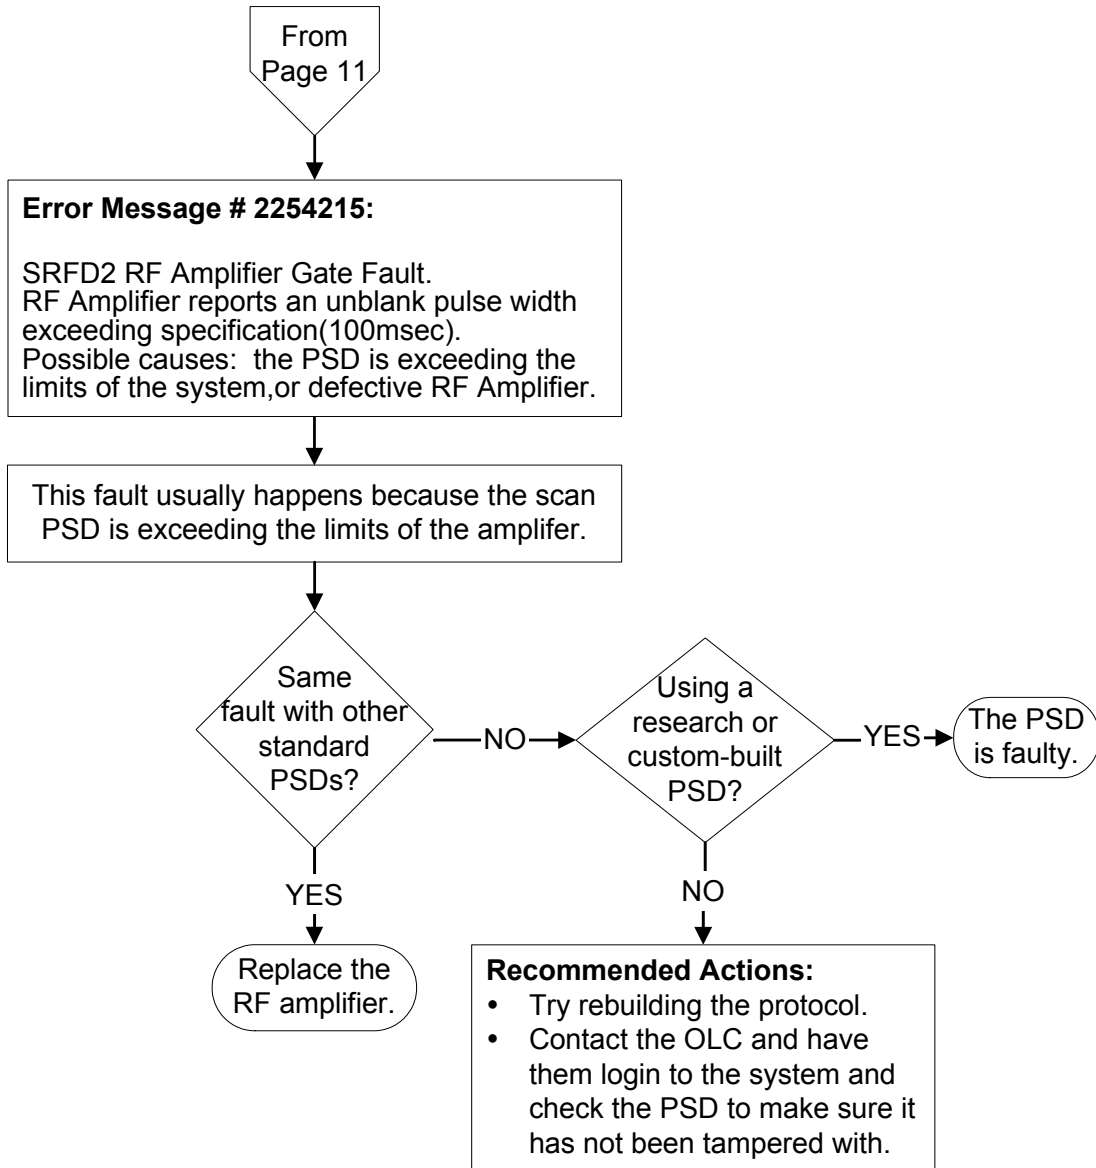
2-21 1.5T SRFD2 Fault Code 2254215

Note:
This error can also occur if the UNBLANK pulse from the SSM is faulty, e.g. Wrong polarity, or not pulsing at all.

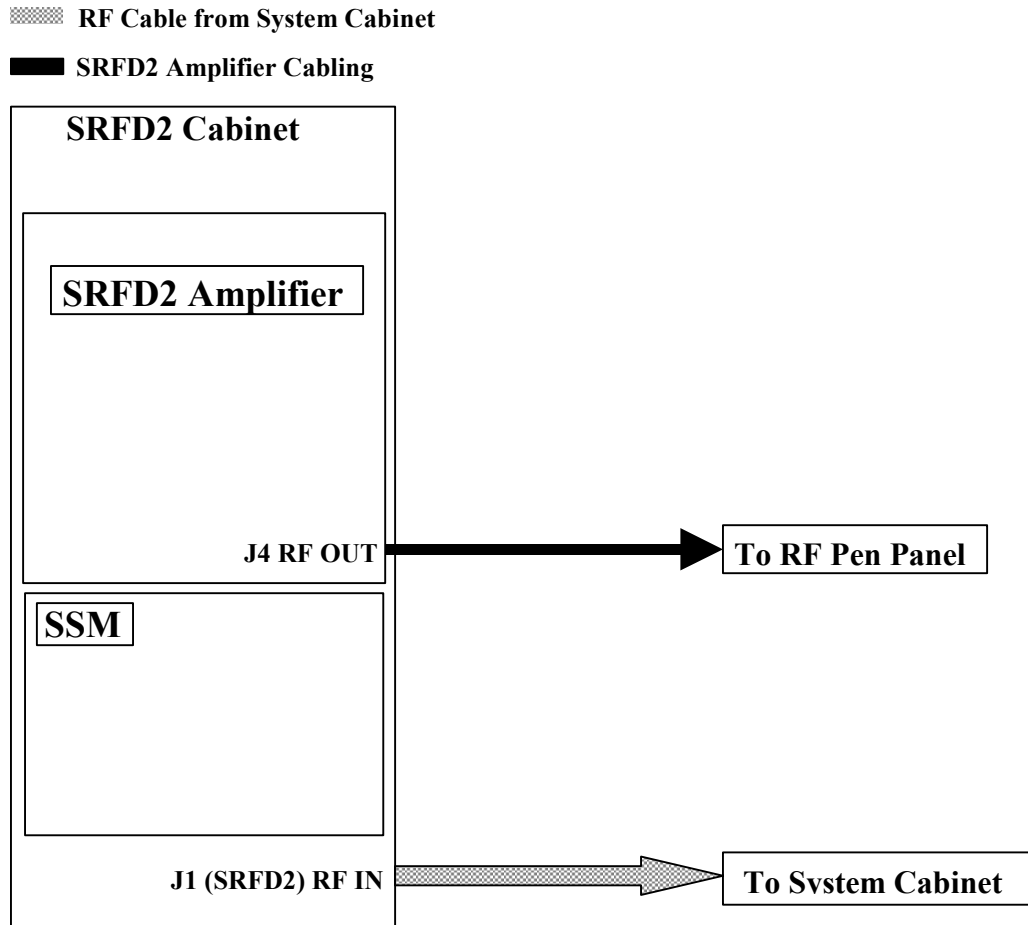
NORMAL SYSTEM CONFIGURATION
ILLUSTRATION 7-1

1. Verify that the system is not scanning.
2. Refer to Illustration 7-1 and reconfigure the system back to a normal configuration.

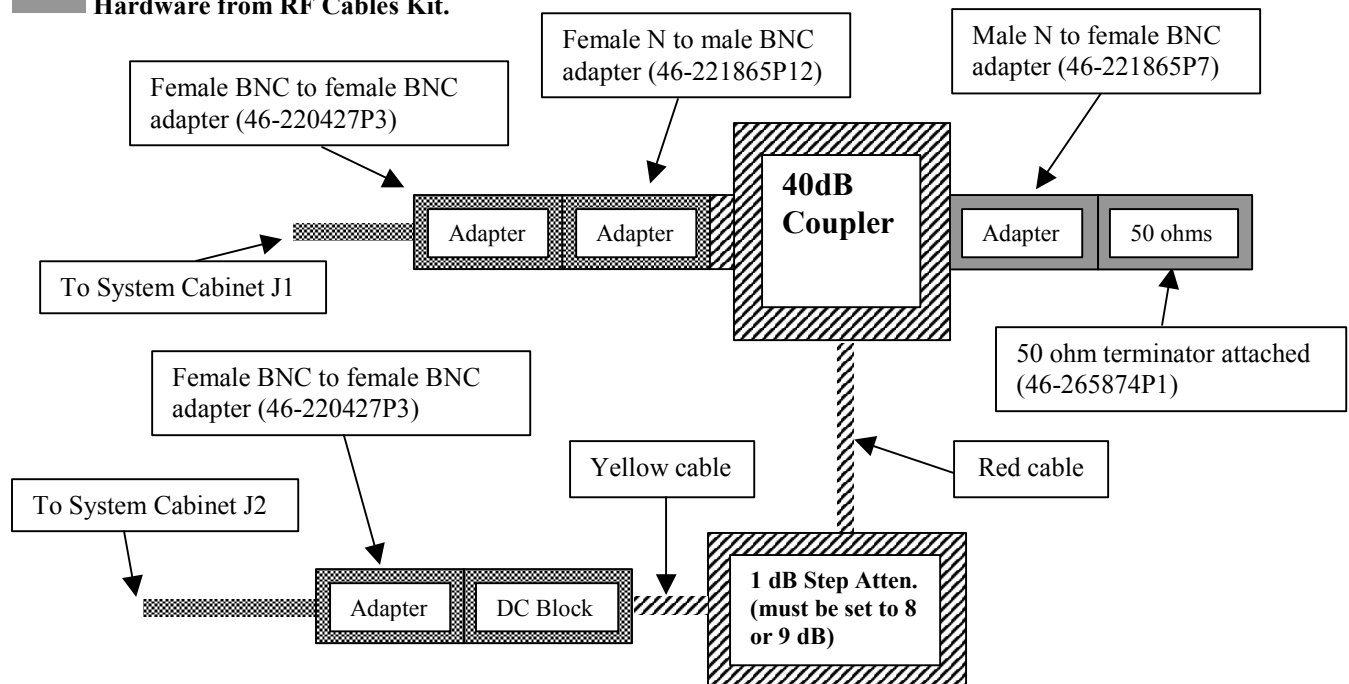
CONNECTIONS FOR MEASURING 40DB COUPLER, CABLES, AND 1DB STEP ATTENUATOR
ILLUSTRATION C-4

RF Power Measurement Kit Hardware under test

Hardware from RF Cables Kit.

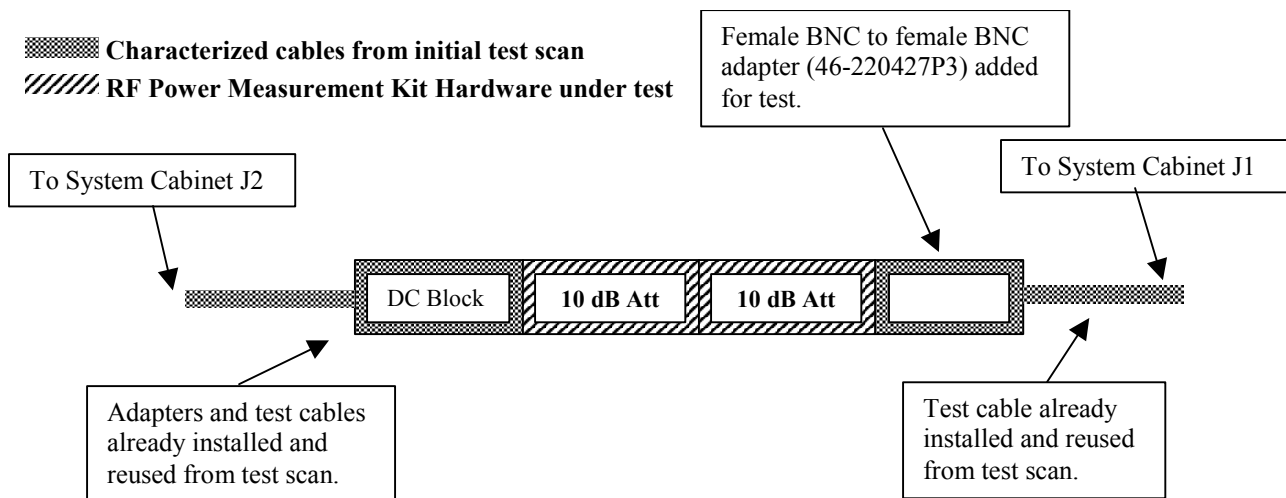
CONNECTIONS FOR MEASURING 10DB FIXED ATTENUATORS
ILLUSTRATION C-5

Characterized cables from initial test scan

RF Power Measurement Kit Hardware under test
