Explanation document MR9150 Introduction DDAS

MR9150
version: 2.2

In this document you are introduced to the **DDAS** hardware, another step in the evolution of our MR scanner.

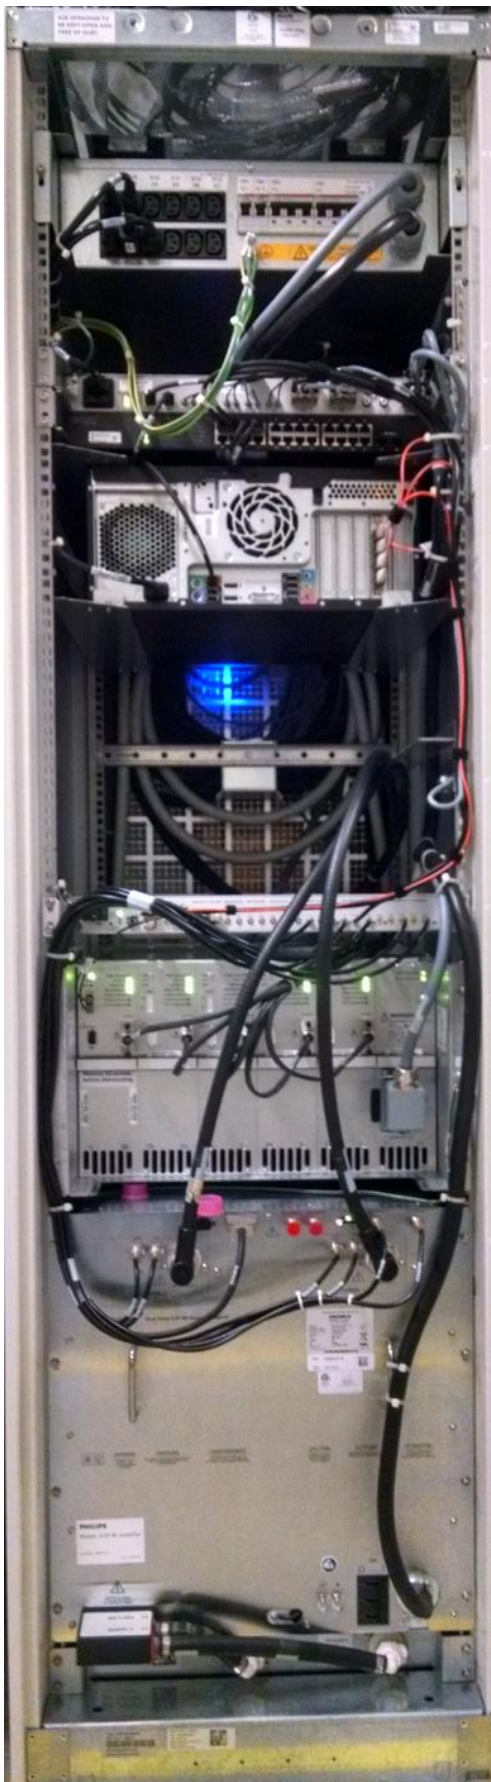
3.10.2 View of the 3.0T ACC

Aibo

Network switch

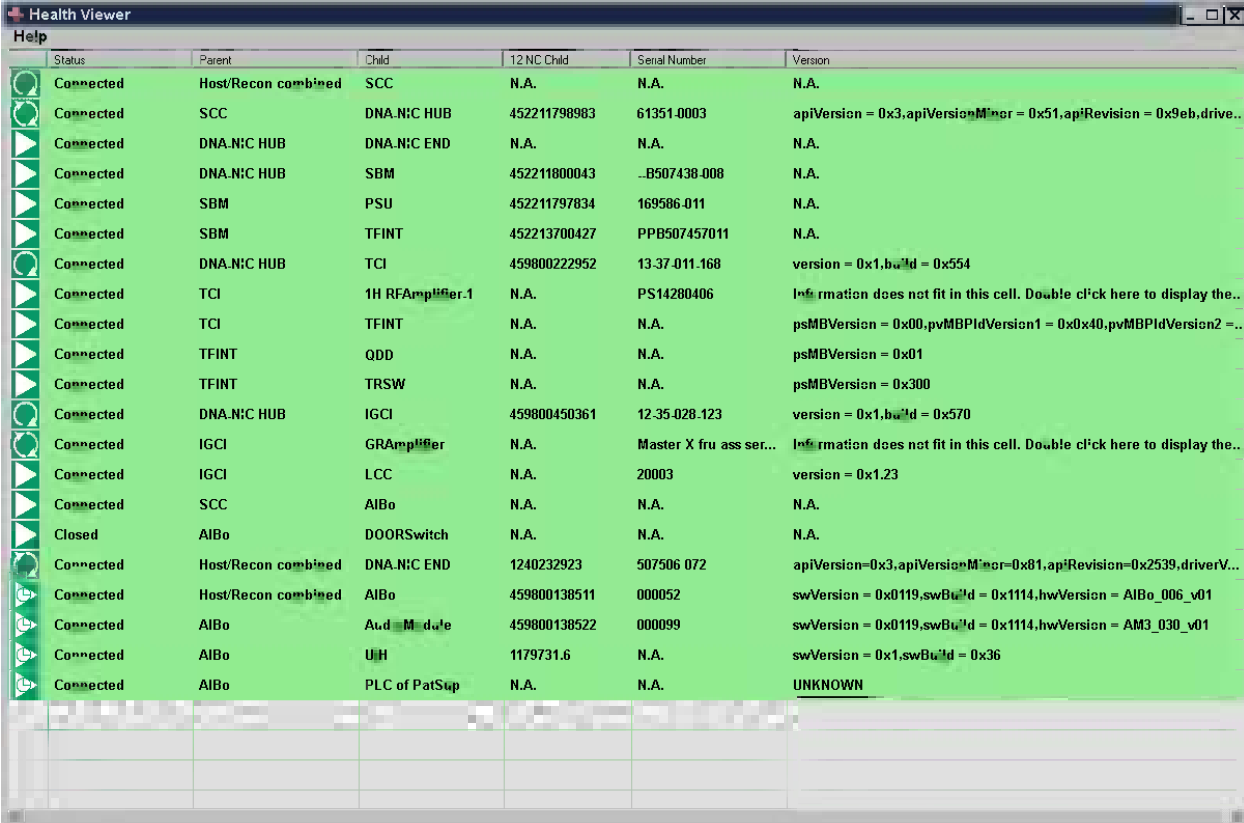
The health viewer shows the status of the connection between two FRU's.

The health viewer is designed as a first step in diagnosing and fault finding the MR system. In case of trouble the health viewer can point to a suspected connection or FRU.

Status	Parent	Child	12 NC Child	Serial Number	Version
Connected	Host/Recon combined	SCC	N.A.	N.A.	N.A.
Connected	SCC	DNA.NIC HUB	452211798983	61351-0003	apiVersion = 0x3,apiVersionMinor = 0x51,apiRevision = 0x9eb,drive...
Connected	DNA.NIC HUB	DNA.NIC END	N.A.	N.A.	N.A.
Connected	DNA.NIC HUB	SBM	452211800043	..B507438-008	N.A.
Connected	SBM	PSU	452211797834	169586-011	N.A.
Connected	SBM	TFINT	452213700427	PPB507457011	N.A.
Connected	DNA.NIC HUB	TCI	459800222952	13-37-011-168	version = 0x1,build = 0x554
Connected	TCI	1H RF Amplifier.1	N.A.	PS14280406	Information does not fit in this cell. Double click here to display the..
Connected	TCI	TFINT	N.A.	N.A.	psMBVersion = 0x00,pvMBPIdVersion1 = 0x0x40,pvMBPIdVersion2 = ..
Connected	TFINT	QDD	N.A.	N.A.	psMBVersion = 0x01
Connected	TFINT	TRSW	N.A.	N.A.	psMBVersion = 0x300
Connected	DNA.NIC HUB	IGCI	459800450361	12-35-028-123	version = 0x1,build = 0x570
Connected	IGCI	GR Amplifier	N.A.	Master X fru ass ser...	Information does not fit in this cell. Double click here to display the..

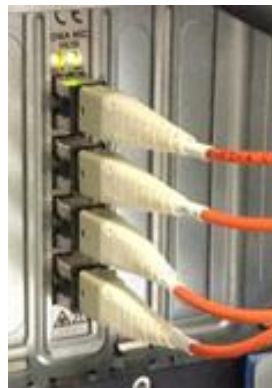
The Health viewer does not support loopback testing for **glass fiber** connections (like in the picture below)

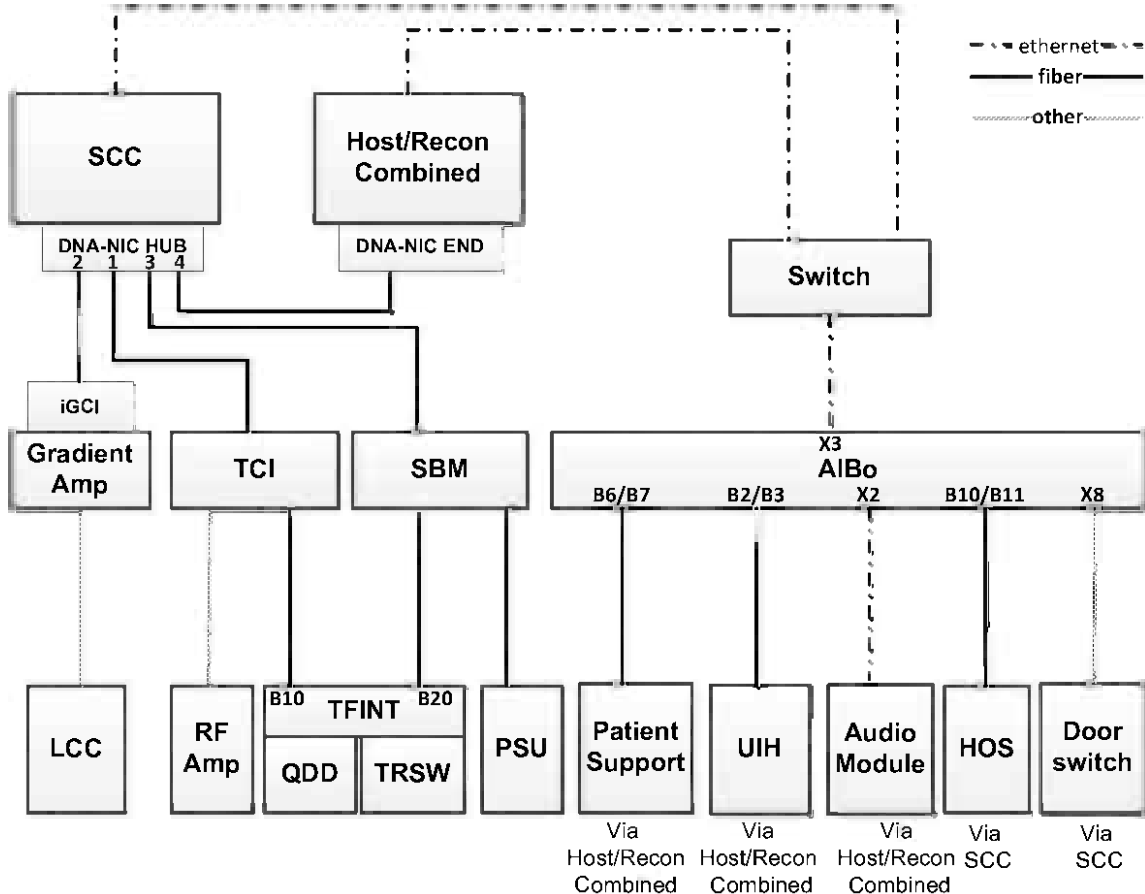
The status of the QDD and the TRSW cannot be determined because of the error in the connection to the TFINT.

Faultfinding this scenario starts with investigating the communication between the TCI and the TFINT.
