FMI ADMINISTRATIVE INFORMATION FMI No: 67601

FMI Title : Magnet Interface Replacement, MFO1 M4 Application Software Installation, and Patch Installation for Signa Ovation System

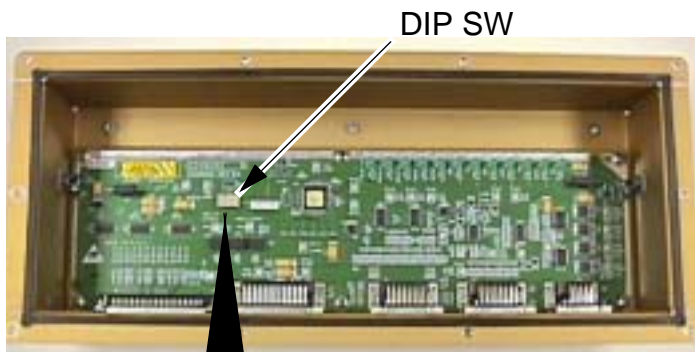
**Magnet Interface Unit
(Removed top cover)**

1. Before installing the new unit, open the top cover of the New Magnet I/F unit by removing the 10 screws.
2. Slide switch 1 to ON position. Switch 2, 3 and 4 are OFF position.
3. Restore top cover of the magnet I/F unit with 10 screws.

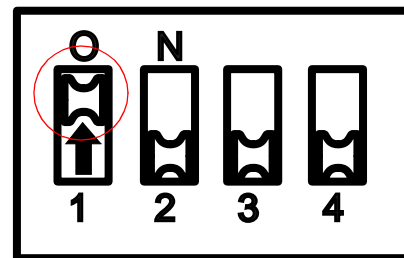
**DIP SW SETTING OF NEW MAGNET INTERFACE UNIT
ILLUSTRATION 1**

For new magnet interface unit (2254366-2), provide a bank of 4 dip switches including a function to select logic of OpenSpeed and Ovation, and this unit is keeping compatibility of OpenSpeed and Ovation by dip switch setting. Differential of logic is a signal condition for collision only.

**Switch 1 should be in the ON position,
2,3,4 are in the OFF position.**

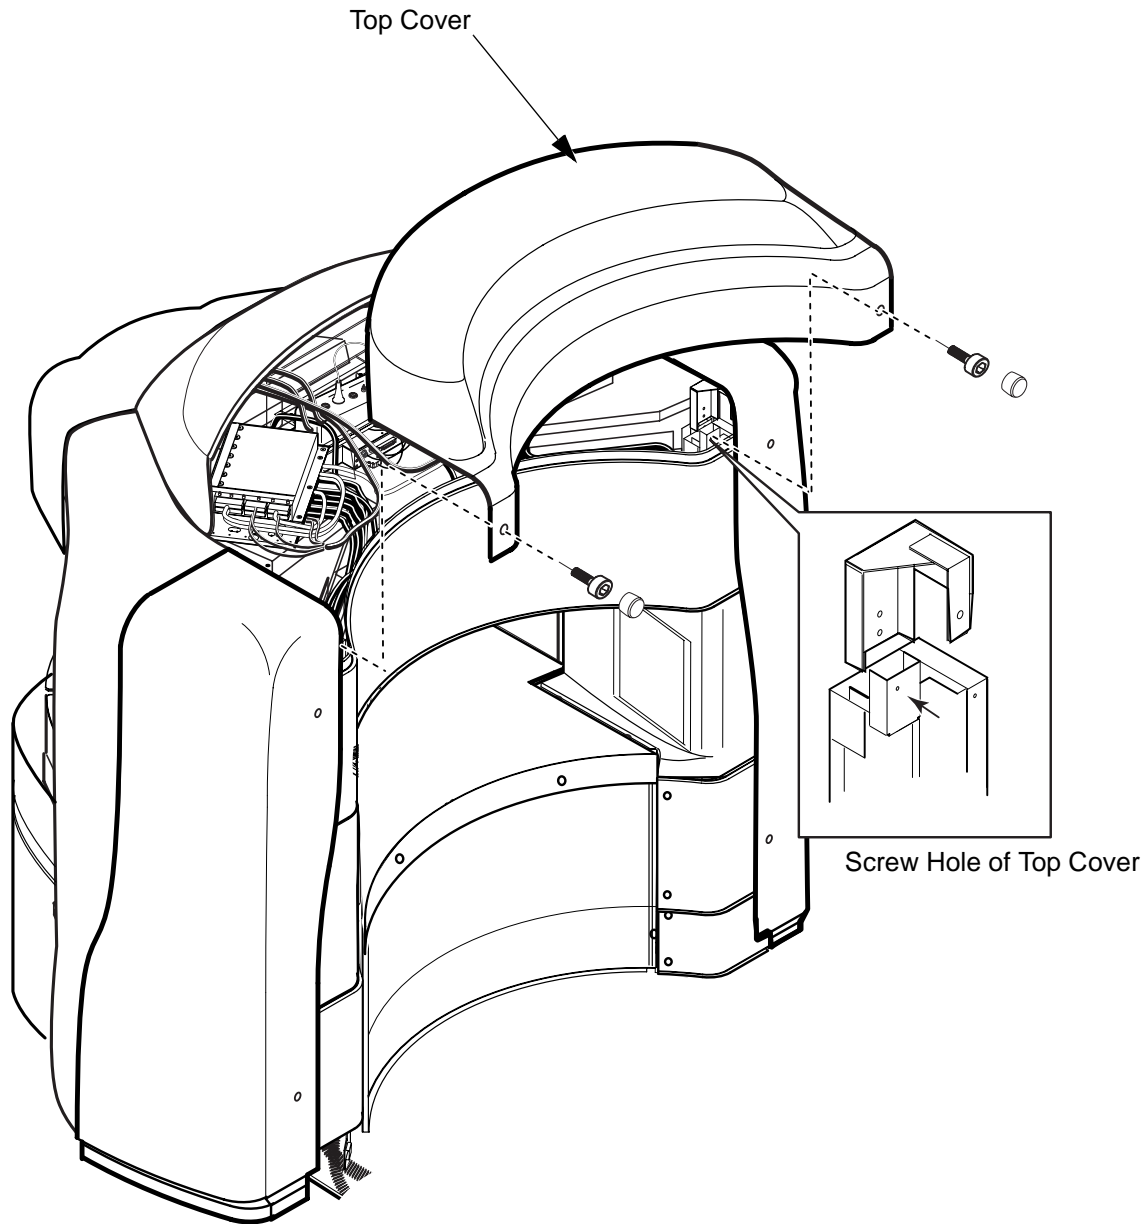
**MAGNET INTERFACE ASSY REPLACEMENT
ILLUSTRATION 2**

4. Remove the Top Cover by removing 2 screws and 2 caps.

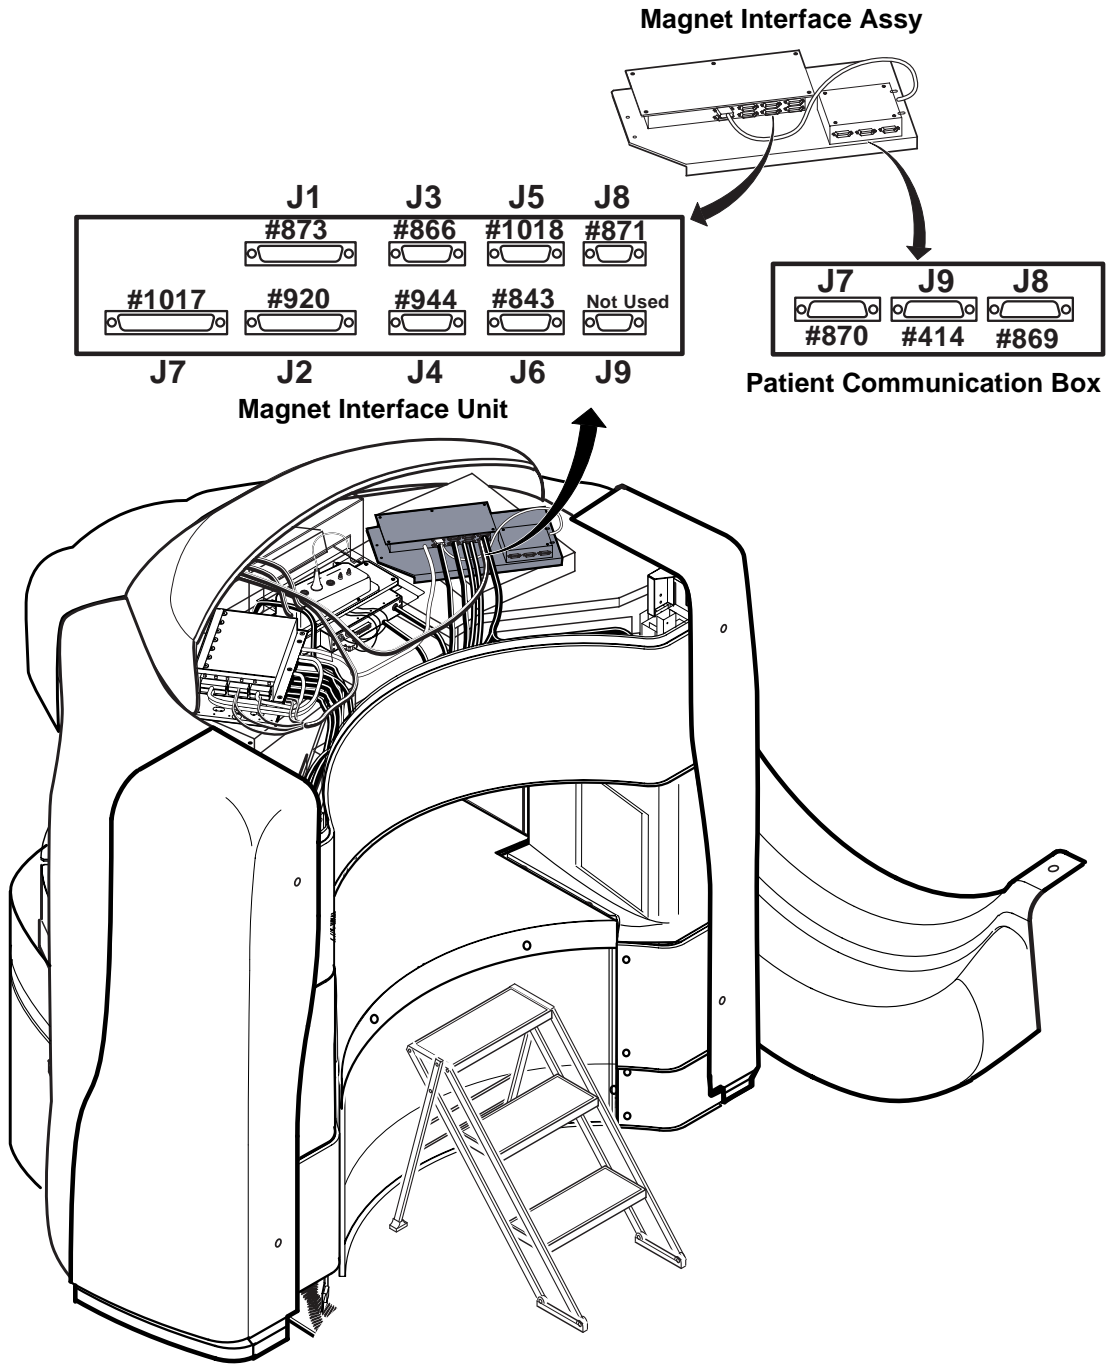
MAGNET INTERFACE ASSY REPLACEMENT
ILLUSTRATION 3

- 5. Disconnect the all cables from the magnet interface assy.

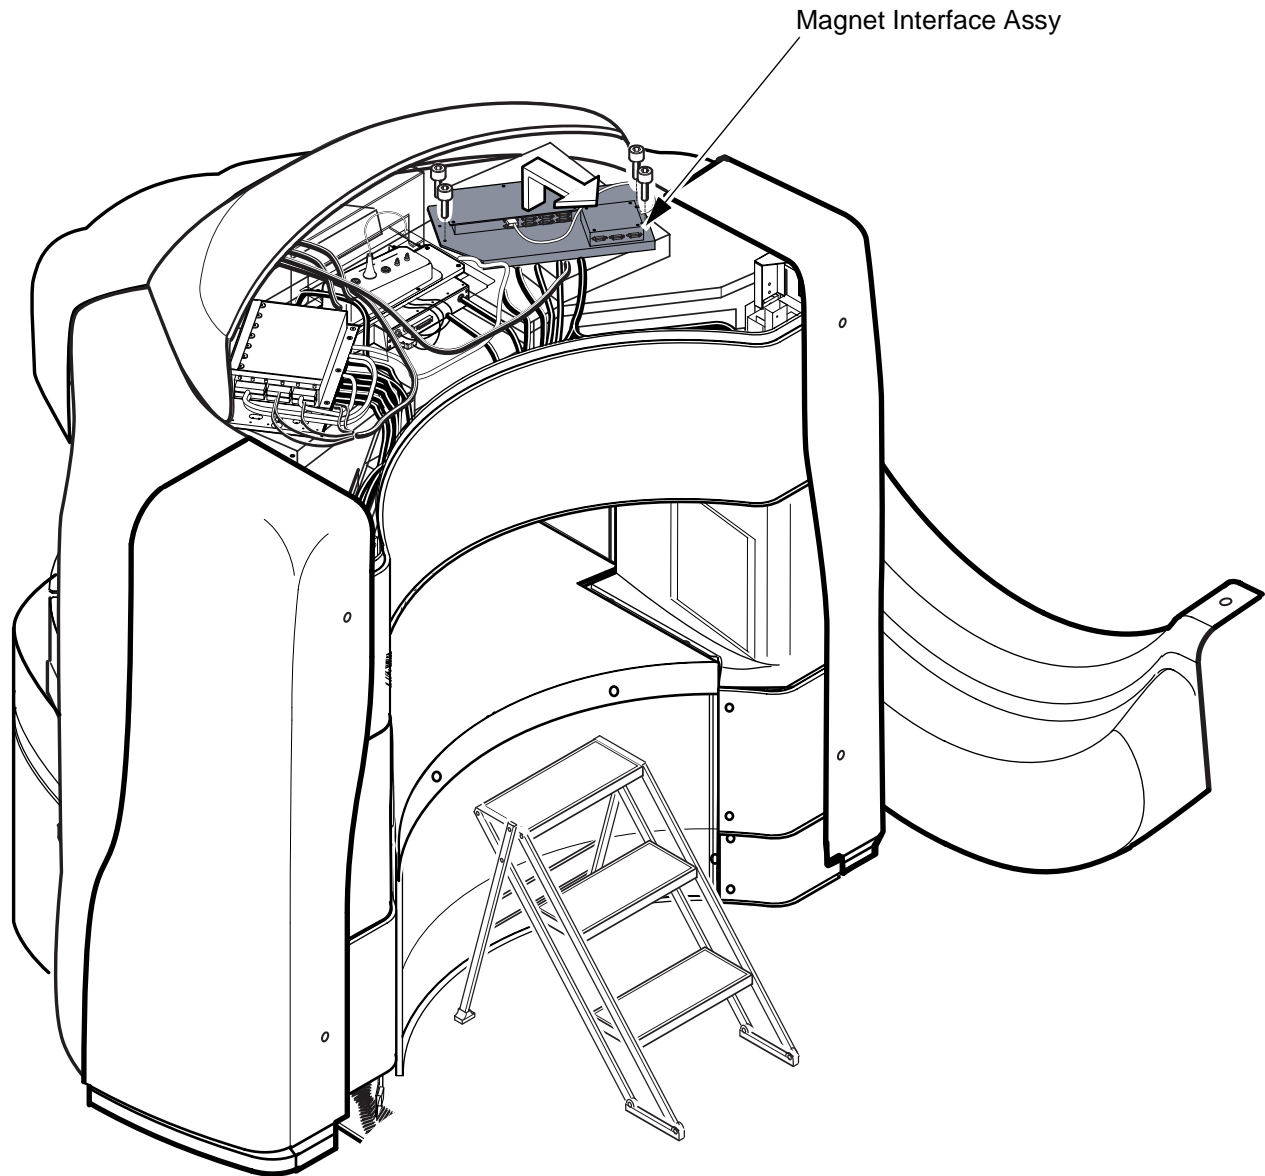
**MAGNET INTERFACE ASSY REPLACEMENT
ILLUSTRATION 4**

6. Remove the magnet interface assy from the magnet top by loosening 4 screws.

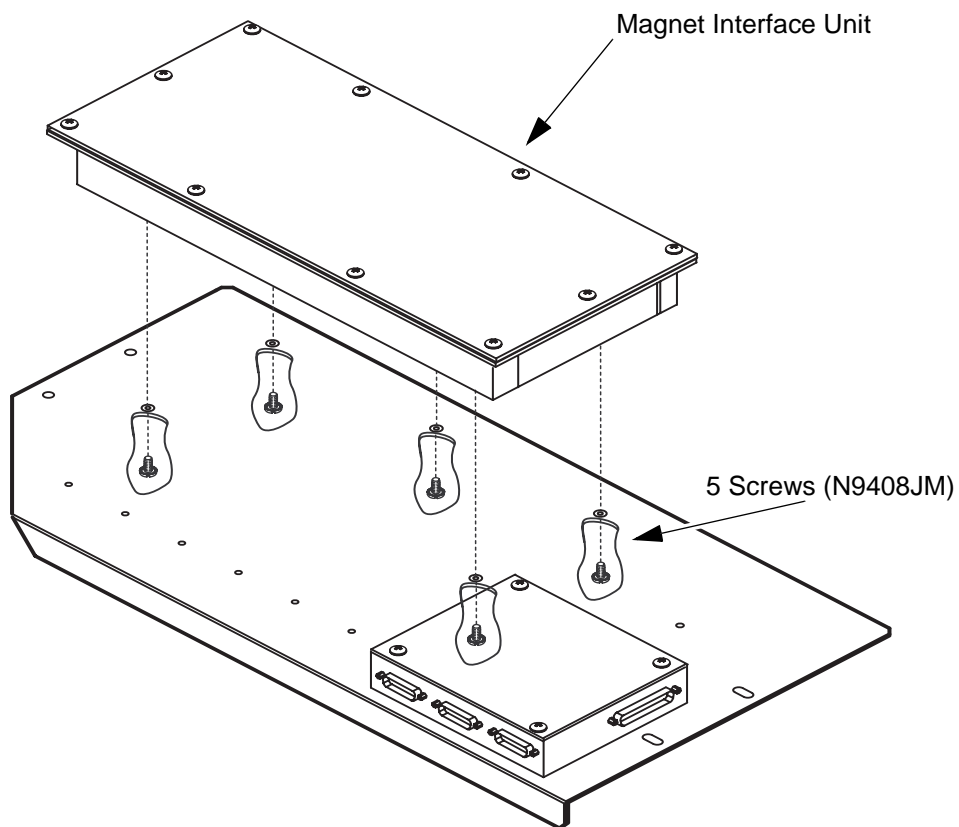
**MAGNET INTERFACE ASSY REPLACEMENT
ILLUSTRATION 5**

7. Remove the magnet interface unit from plate by loosening 5 screws (N9408JM).

8. Install new Magnet Interface Board by the reverse order of removal.

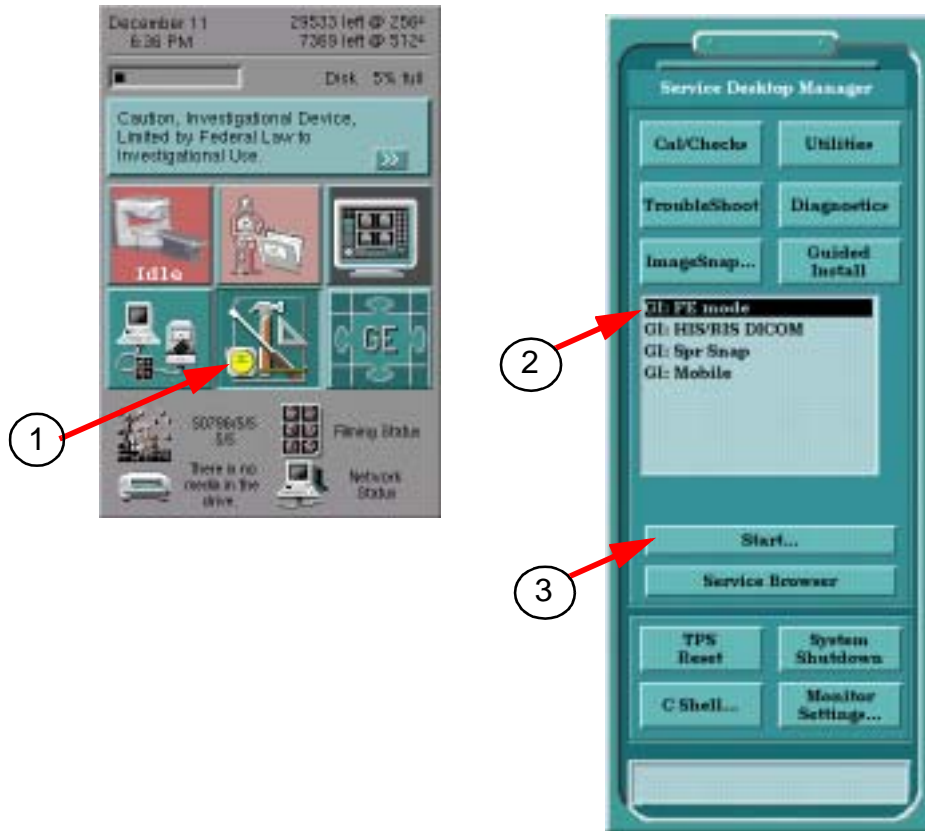
SERVICE DESKTOP
Illustration 2

1. Select [**Service Desktop**] icon.
2. Select "**GI: FE mode**".
3. Click [**Start**].

4. Enter "operator" and hit [Return] key.
Password: **operator [Return]**

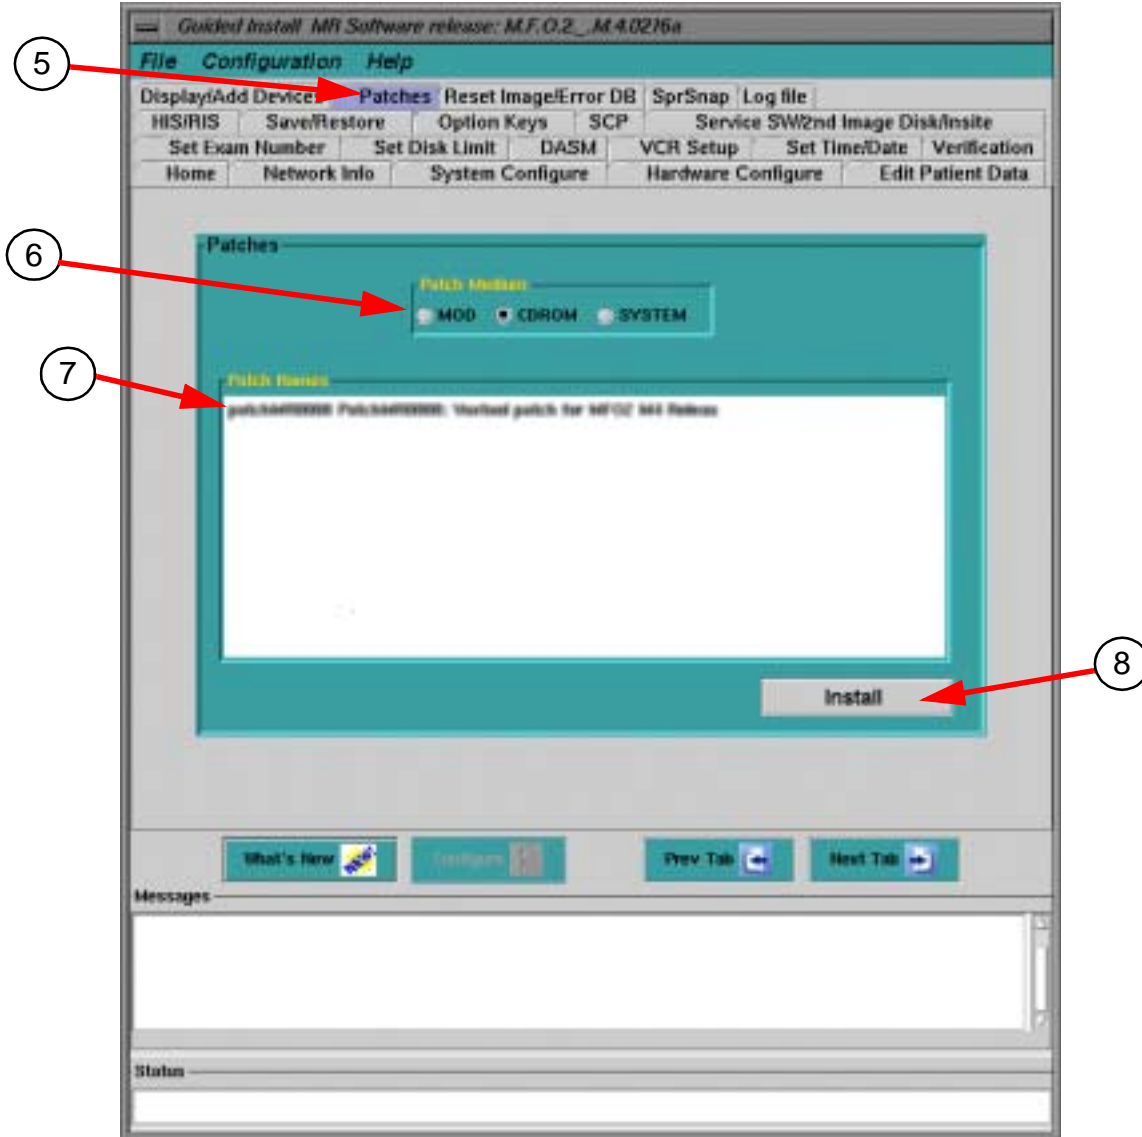
GUIDED INSTALL SCREEN
ILLUSTRATION 6

5. Guided Install Screen comes up. Click [Patch] tab.
6. Select Patch CD-ROM.
7. Select Patch Name.
8. Click [Install]. Patch Software will be installed.

9. Select "System" from patch medium. Verify that installed patch name is displayed in the patch name area.
10. Select "File" and select "Quit". Select "OK" at the message.
11. Reboot the System.
